UNDERWATER ARCHAEOLOGY PROCEEDINGS
FROM THE SOCIETY FOR HISTORICAL
ARCHAEOLOGY CONFERENCE

ALAN B. ALBRIGHT, *Editor*

Society for Historical Archaeology
Savannah, Georgia 1987

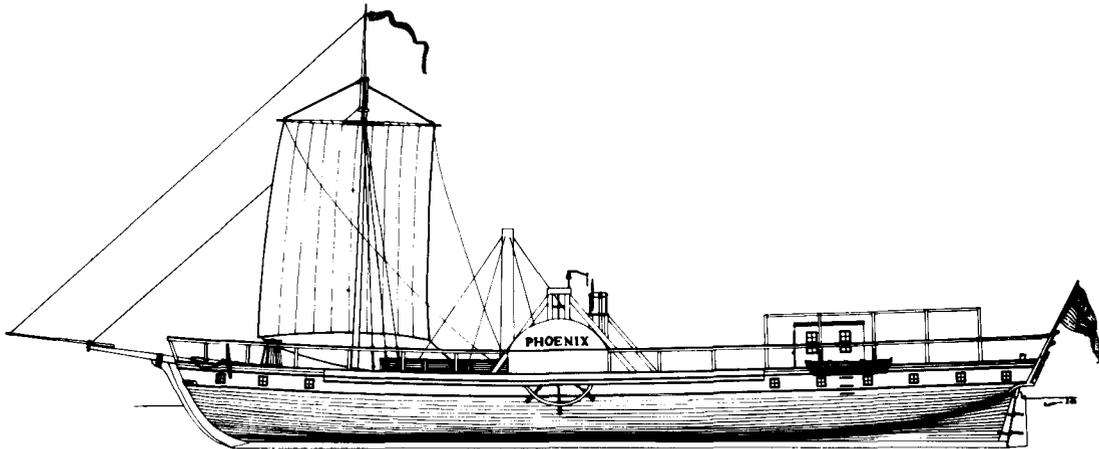
FIGURE 1. Lake Champlain Transportation Company steamer *Phoenix* which plied the lake for four years until destroyed by fire in 1819. The drawing is based upon archaeological measurements of the hull and contemporary plans of similar steamers.

Our first project was the study of the steamboat *Phoenix* (Figure 1). Built in 1814, the *Phoenix* is believed to be the oldest surviving steamboat hull in the world. She burned in a violent conflagration in 1819 in which six lives were lost, and eventually came to rest on a rocky reef in the middle of Lake Champlain in 60-110 feet of water. Our project produced a wreck site plan, historical documentation and publication of results. Over the next several years we instituted a program of systematic inventorying of the States underwater resources, and the documentation of selected sites. We found a total of four, and have fully documented two forgotten American watercraft known as sailing-canal boats (Figure 2). We have located the Revolutionary war row-galley which served as Benedict Arnold's flagship during the Battle of Valcour Island, and a Revolutionary war bridge that spanned the Lake at Fort Ticonderoga. One crew has located and produced a photomosaic of a rare horse-powered ferry.

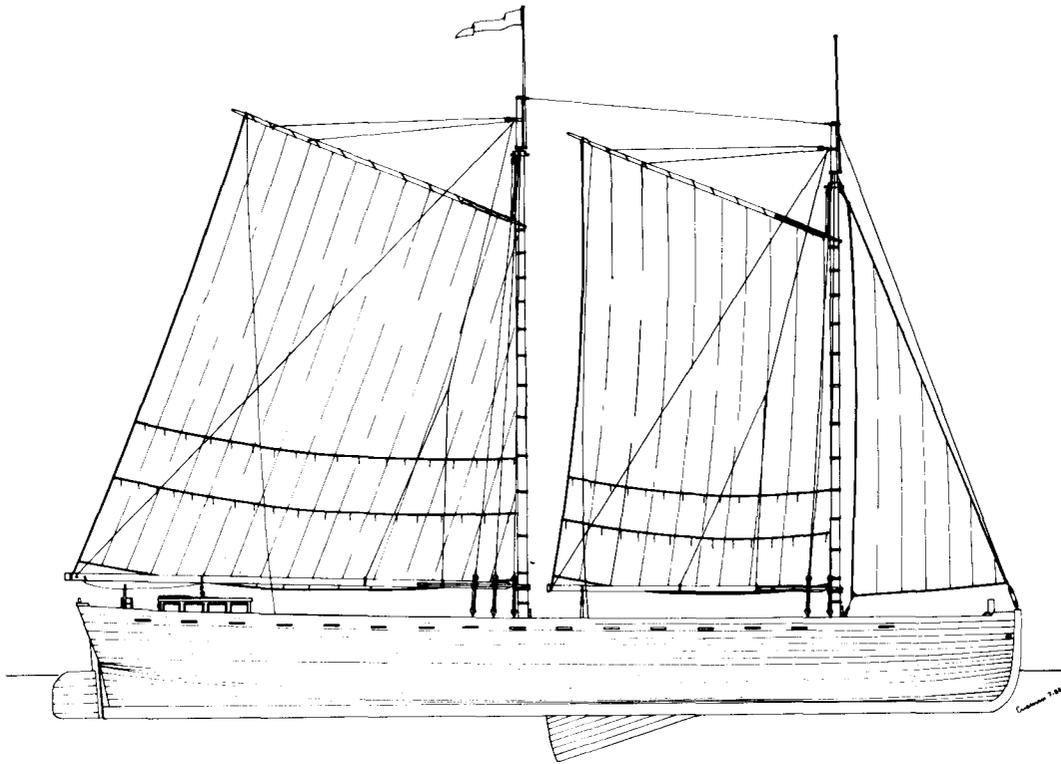
FIGURE 2. The canal schooner *General Butler*. A retractable center board and folding masts permitted her to pass through the narrow locks of the Champlain Canal

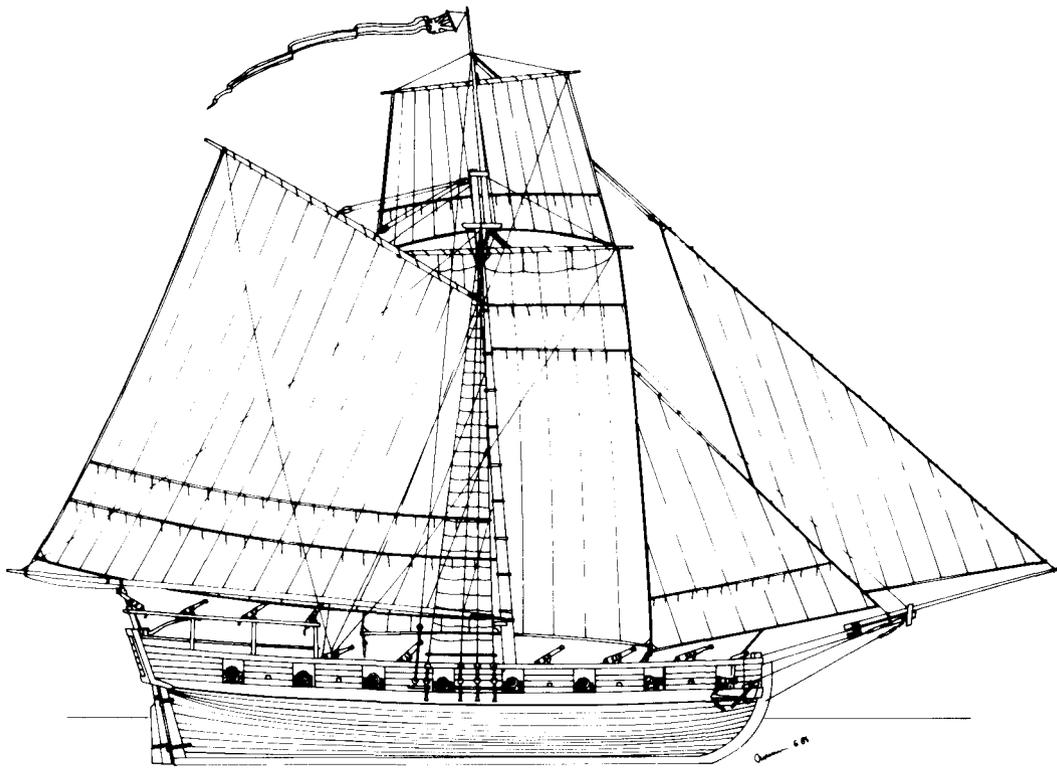
FIGURE 4. British 16 gun sloop *Boscawen*. This conjectural drawing is based upon archaeological measurements of the sunken hull, and upon contemporary paintings of the sloop.

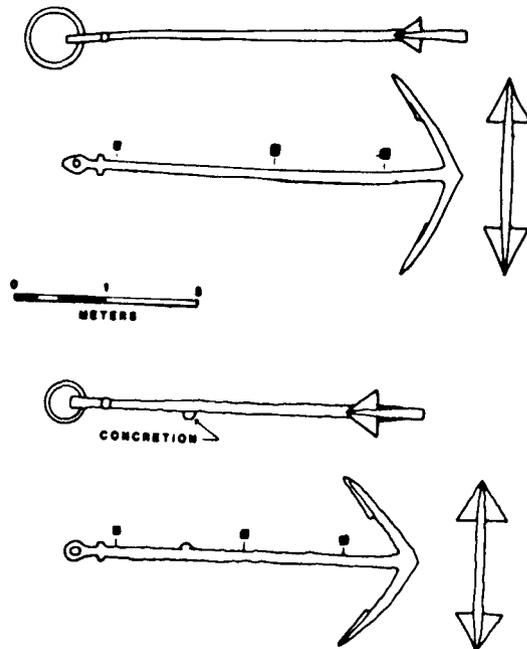
FIGURE 2. Comparative features of the two anchors at MN 10-13a. Upper drawing is the cleaned specimen recovered by T.A.C., and the lower drawing is the uncleaned specimen exposed during 1986. Upper anchor is redrawn after Arnold and Weddle (1978: Figure 110).

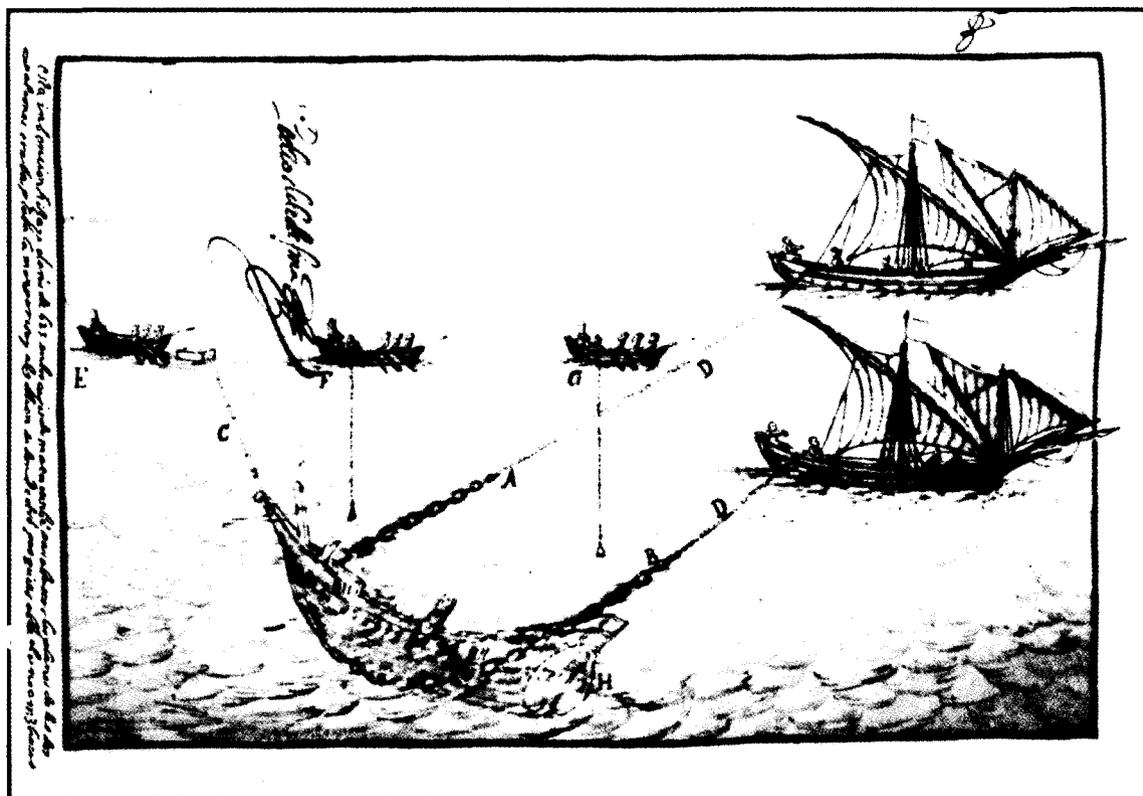
FIGURE 3. A rendering of the salvage technique used by Pedro de Ledsma in 1623 (after McDonald and Arnold 1979: Figure 28).

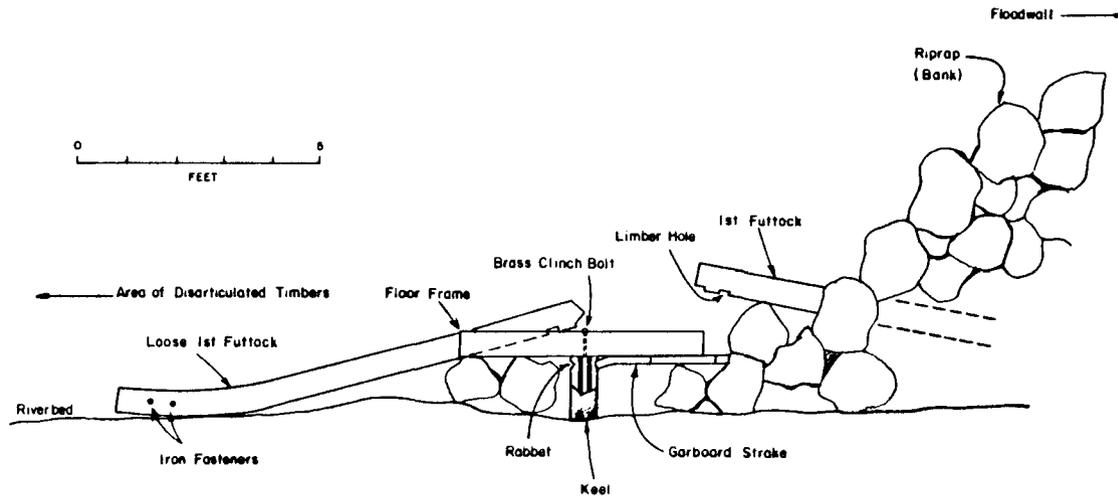
FIGURE 2. Side view at southern end of main wreckage area, Target 5

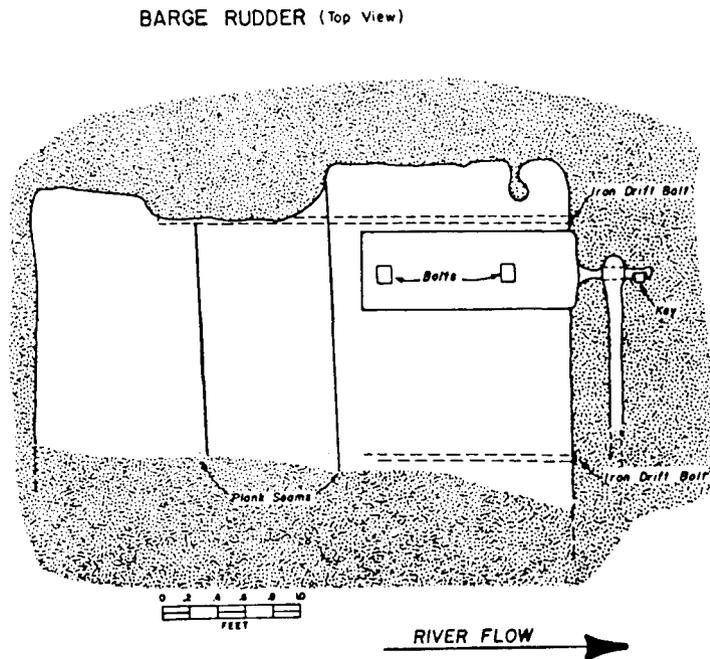
FIGURE 4 . Target 9, Barge rudder

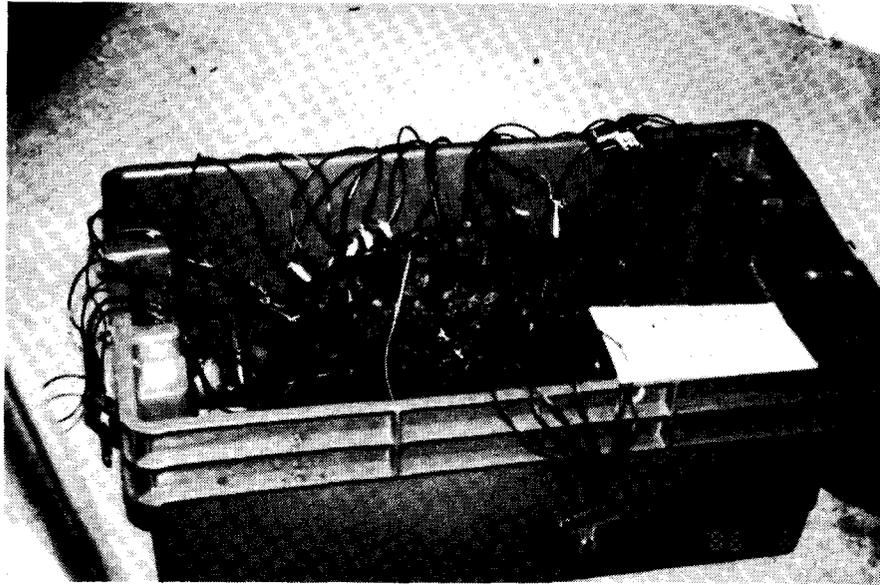
FIGURE 1. Concretion prepared for electrolysis

Preparation for electrolysis began with the careful insertion of metal pins or probes into the concretion. Tiny holes were drilled to reach artifacts viewed in the x-rays. Metal pins inserted in these holes were attached with multistrand copper wire to a D.C. power supply. Exposed artifacts were attached with small clips. The electrolyte was a 2% NaOH (sodium hydroxide) solution (Figure 1).

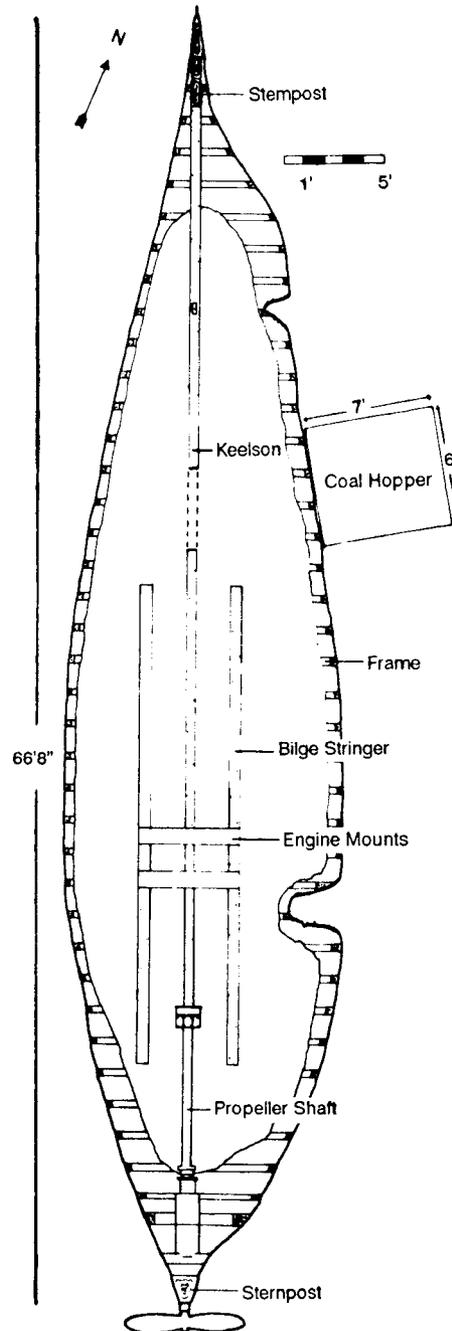
FIGURE 2. Top view of the hull remains

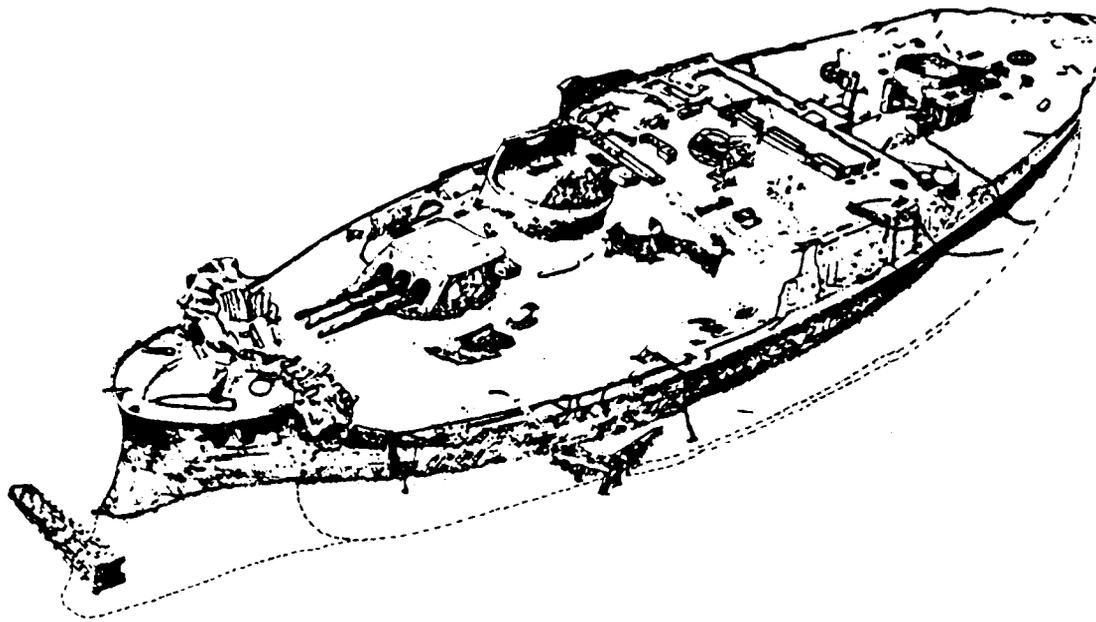
FIGURE 1. Perspective View from the Bow

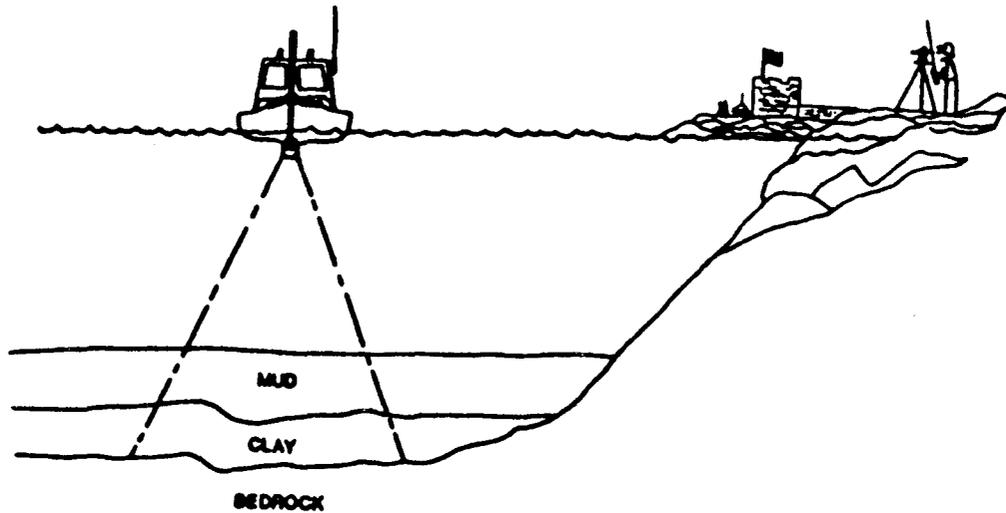
FIGURE 3. Schematics range from the highly technical rendition to cartoon-like drawings, but they are always packed with information (courtesy of the ANGEL GABRIEL Project, MAHRI)

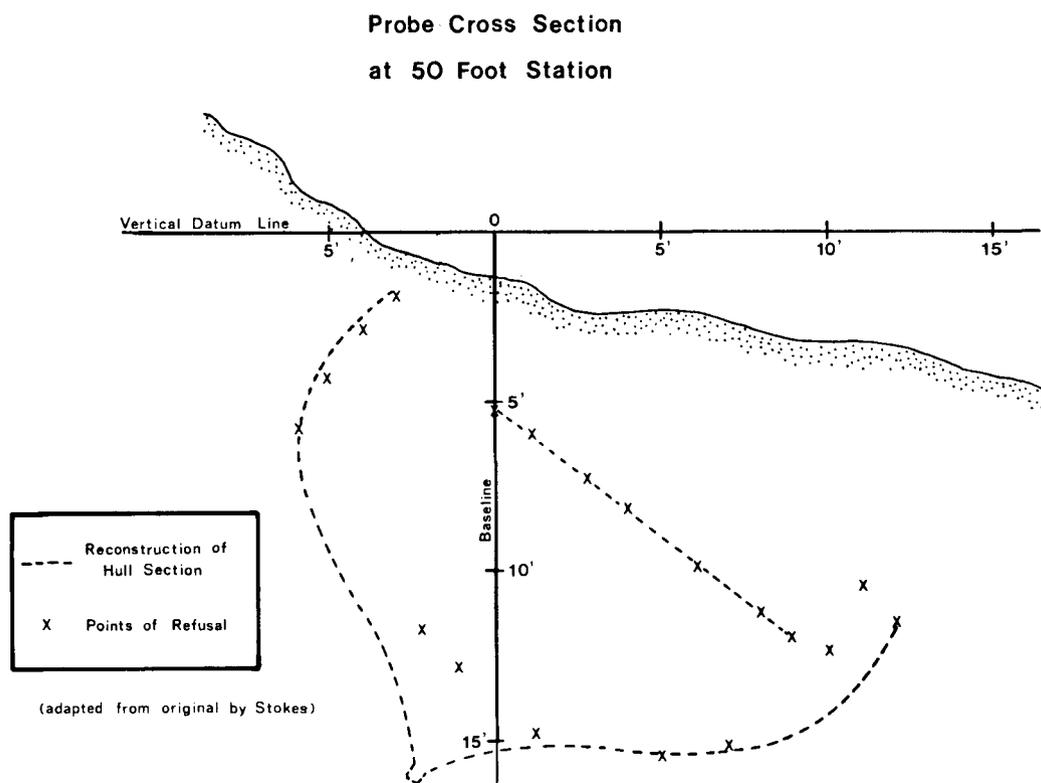
FIGURE 2. Probe cross section at 50 Foot Station

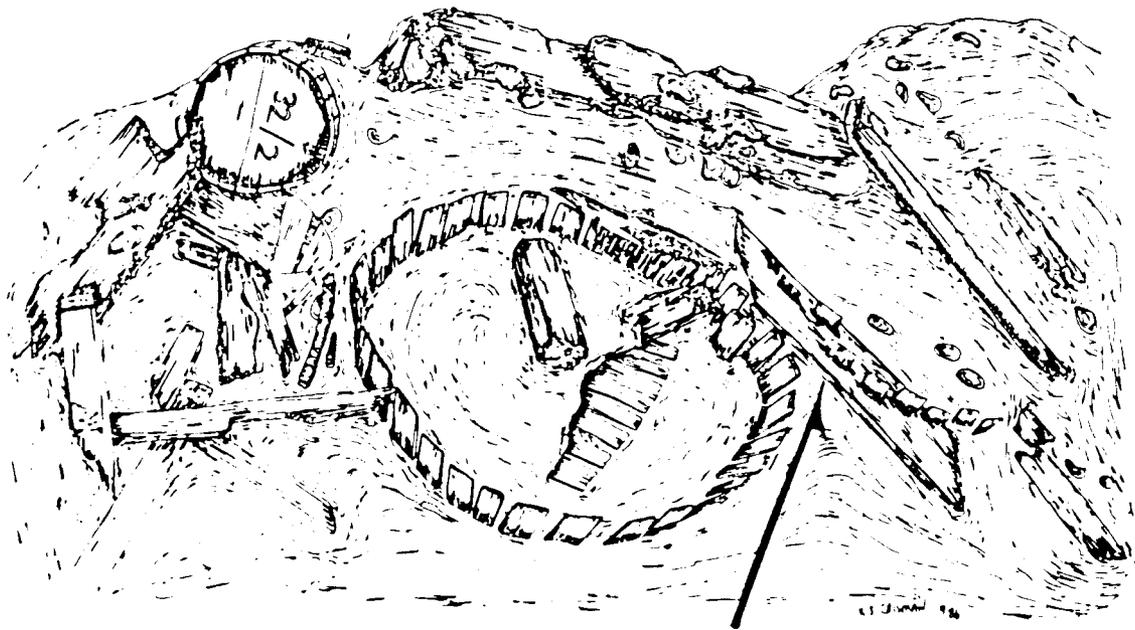
FIGURE 1. Sketch of area just aft of foremast, facing forward. Arrow indicates staves penetrating a deck plank. (Sketch by Kevin Crisman)

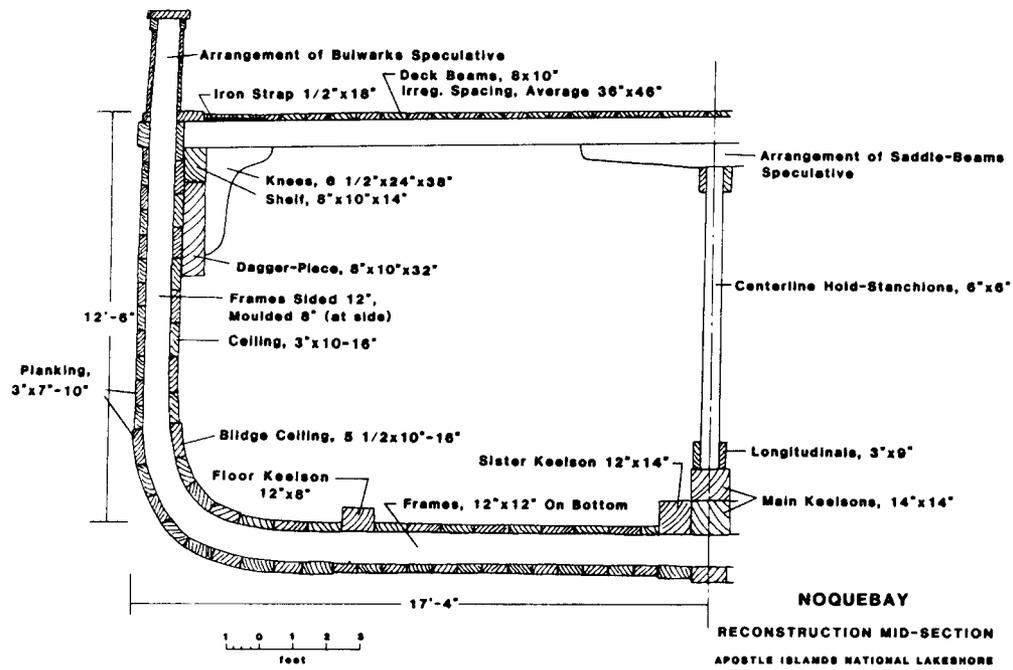
FIGURE 3. Hull Cross Section

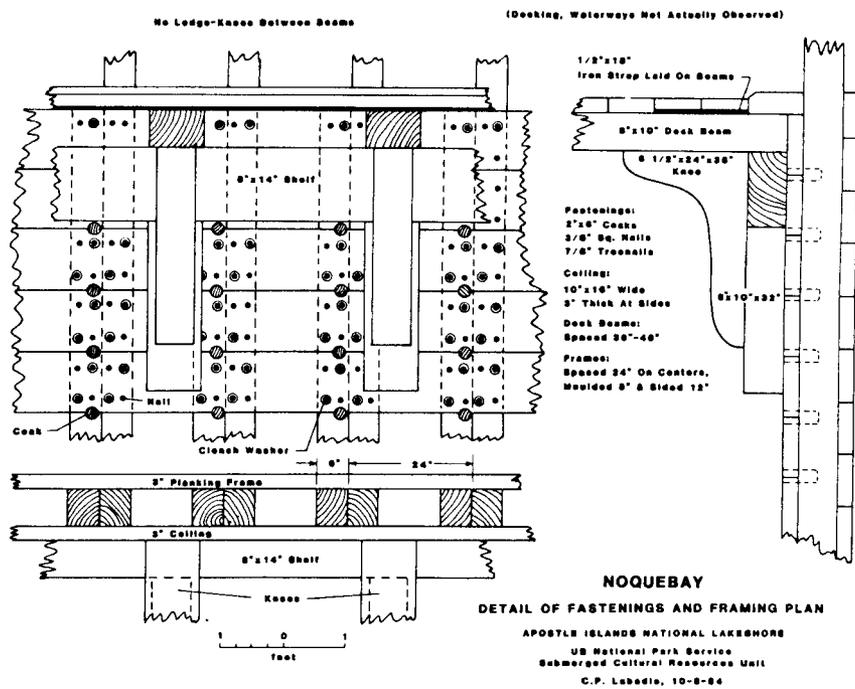
FIGURE 4. Detail of fastenings and framing plan

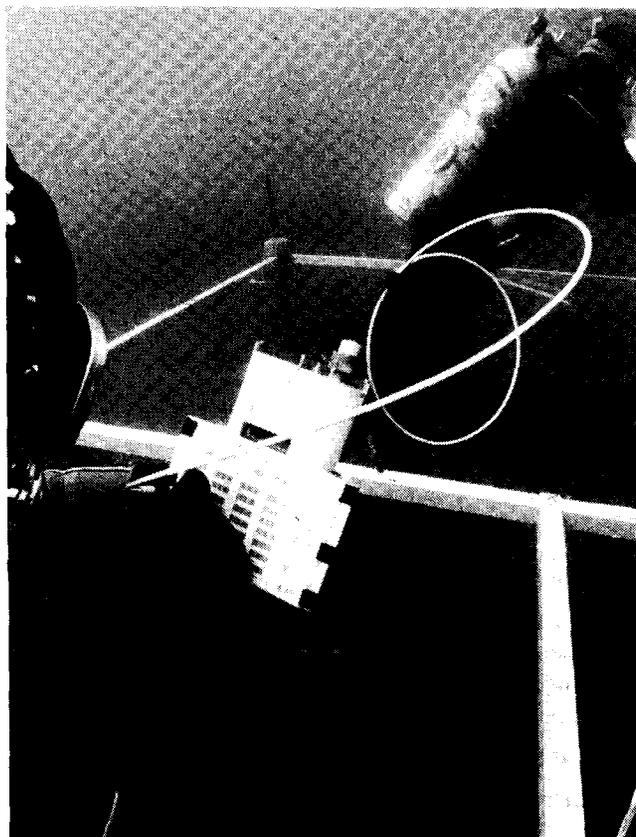
FIGURE 1. The diver-operated computer (SUB-C-DAS)

Two SUB-C-DAS units and the software were evaluated in October 1986. These included the prototype unit and Mark II (Figure

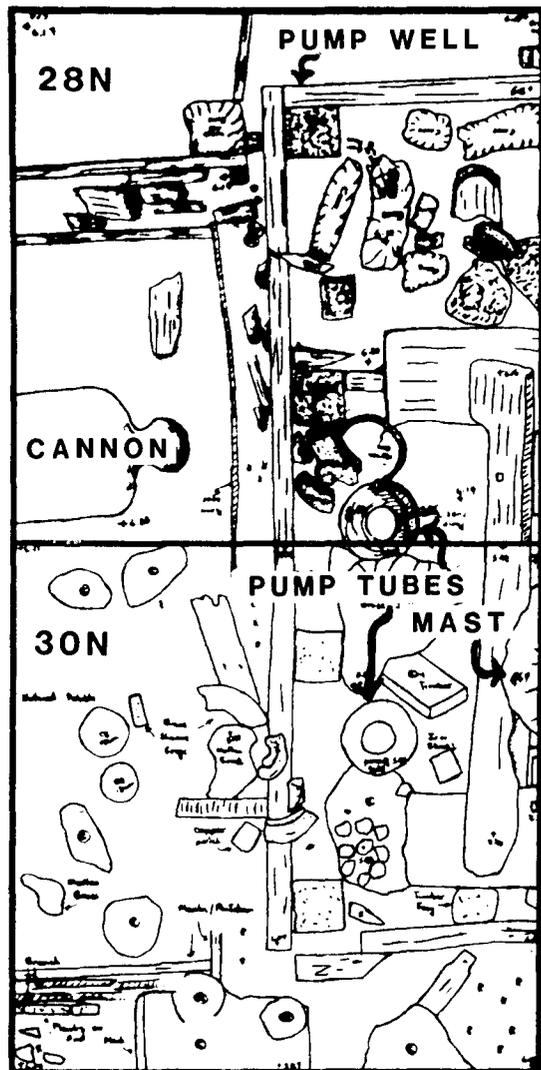
FIGURE 2. Gridded area of Louisbourg wreck in which mapping with SUB-C-DAS was conducted (2 x 4 meters).

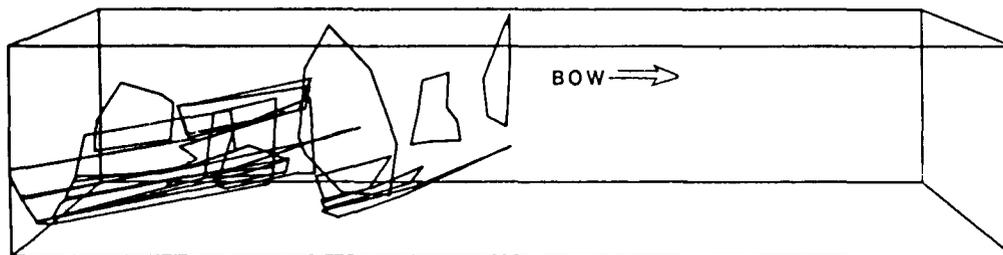
FIGURE 3. Example of computer-generated data from a schooner wreck.

advantage of SUB-C-DAS plotting over conventional mapping is the storage of x, y, and z coordinates in the database. With conventional mapping, the diver determines the x, y, and z coordinates visually and draws the appropriate points and lines, but does not retain real numbers in the data record. With SUB-C-DAS plotting, these values are retained and in fact the dimensions of objects can be accurately determined from the database once the coordinates have been entered.

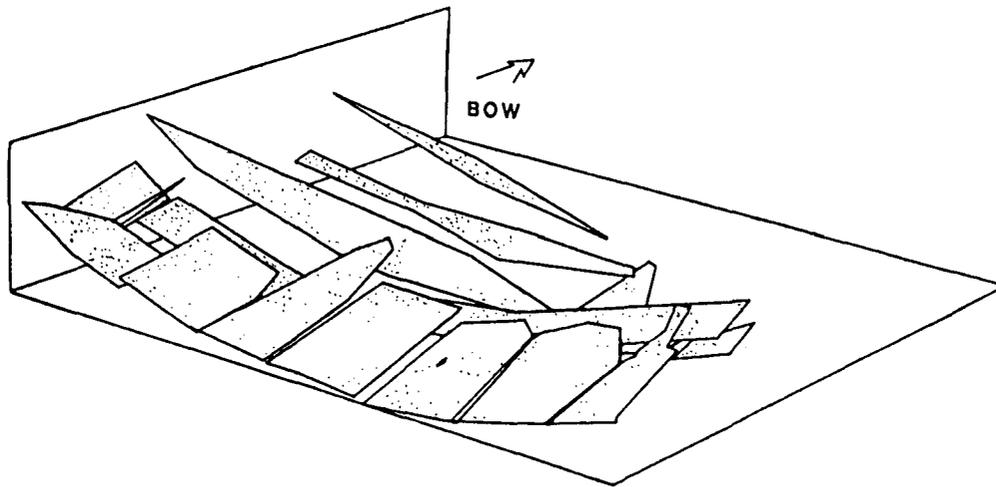
FIGURE 4. Oblique view of the data in Figure 3 with hidden lines removed.

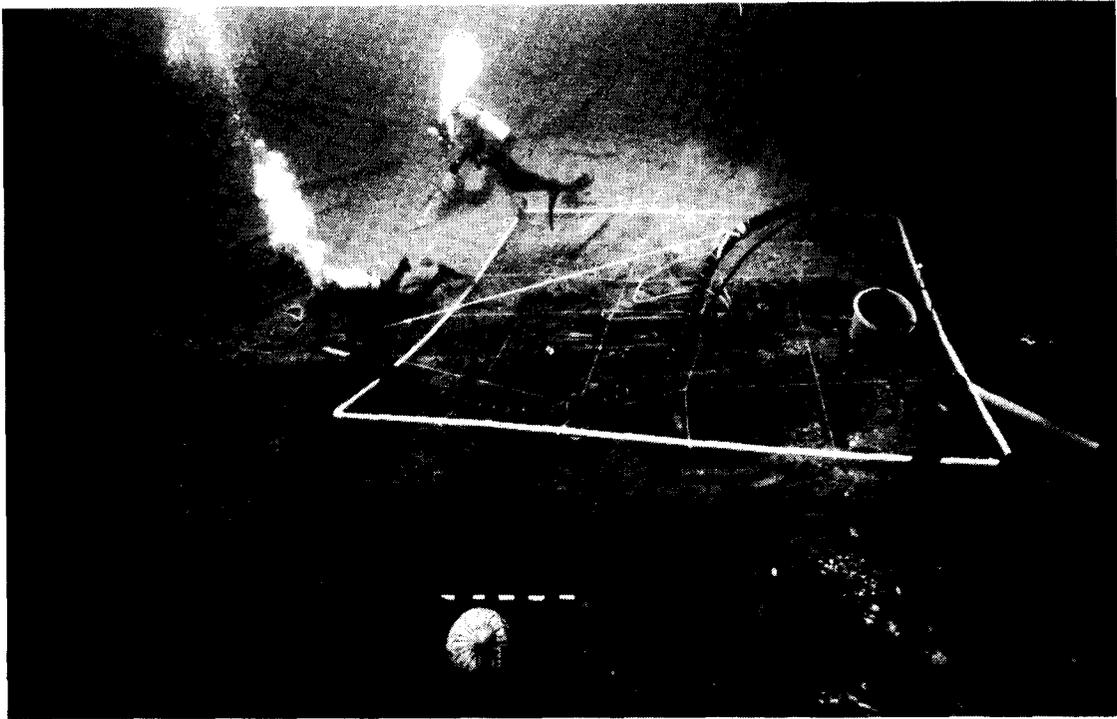
FIGURE 1. Continuous, systematic excavations, proceeding from the flat lying portside started in 1984. Some cannons still rest in their gunports. (Photo: Nils Aukan/Kalmar County Museum).

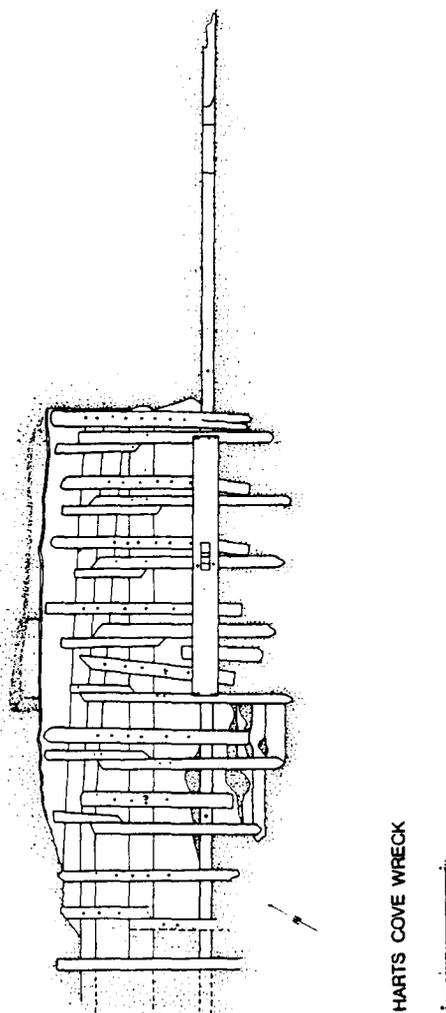
FIGURE 1. 1986 Hart's Cove Wreck preliminary plan

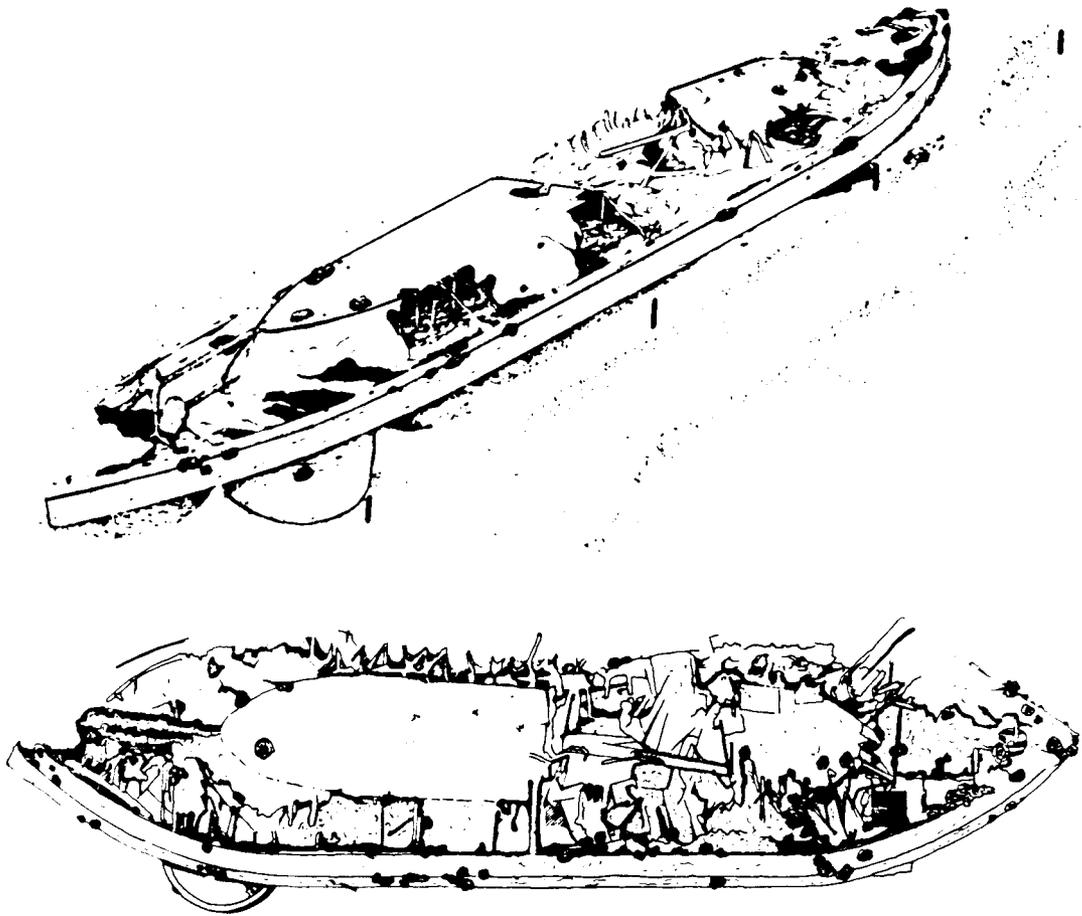
FIGURE 1. Artist rendering of the remains of USS *Monitor*

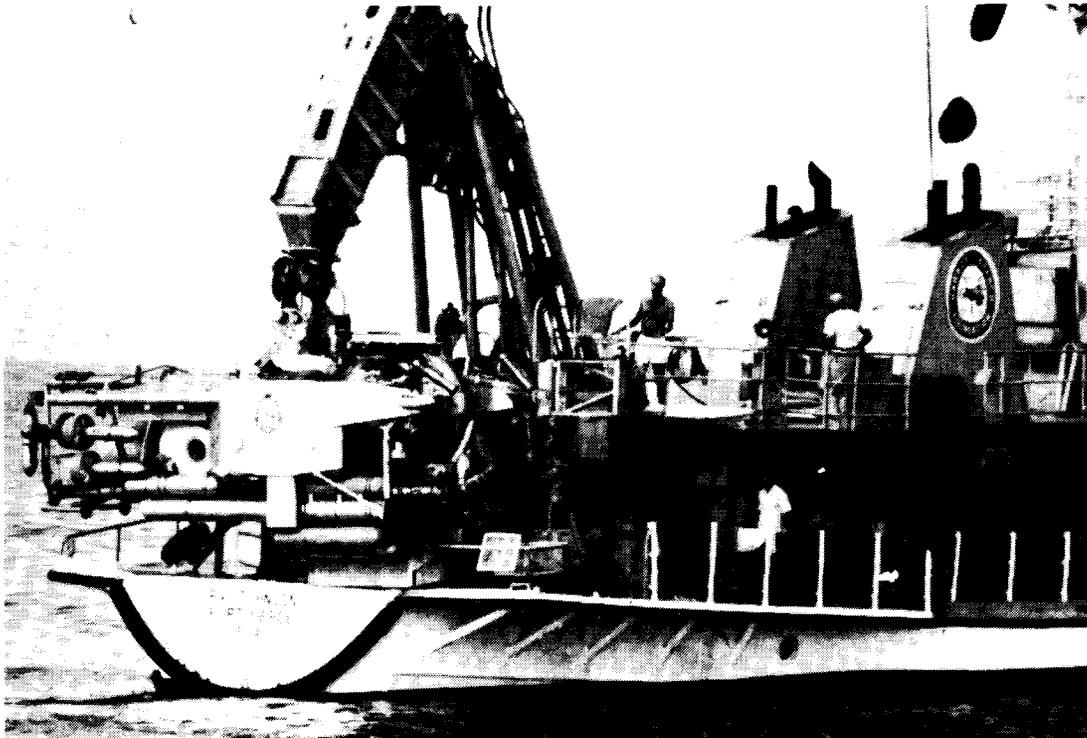
FIGURE 3. *Johnson-Sea-Link* submersible aboard the R/V *Johnson*

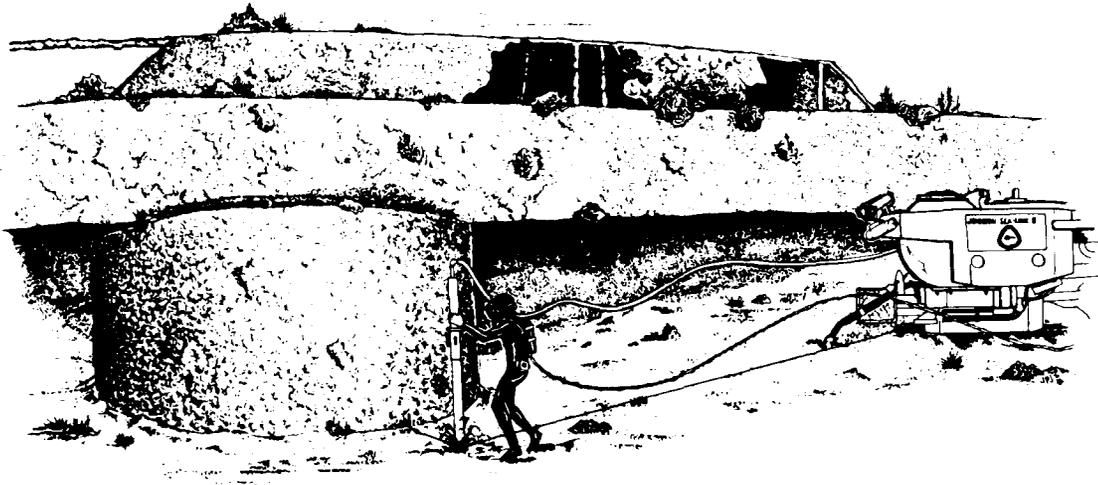
FIGURE 4. Artist rendering of datum casing placement.

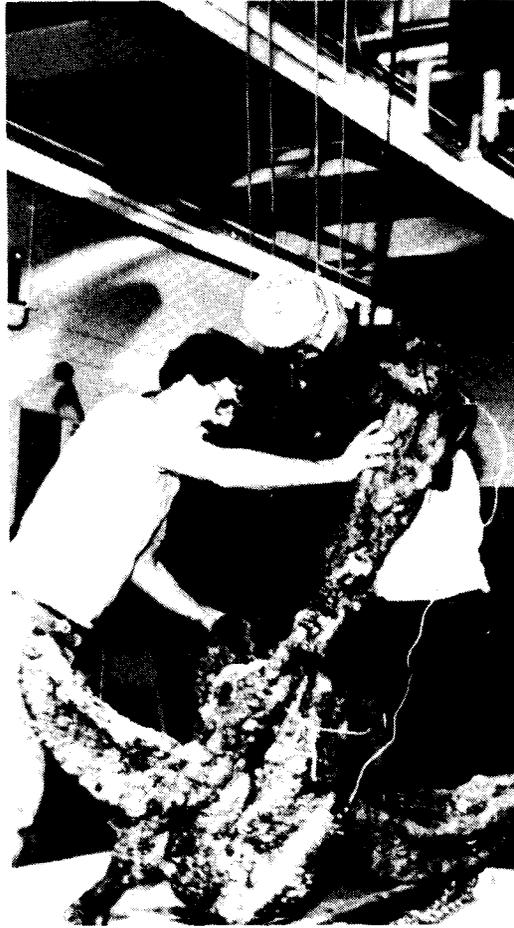
FIGURE 5. Anchor conservation.
