UNDERWATER ARCHAEOLOGY PROCEEDINGS
FROM THE SOCIETY FOR HISTORICAL
ARCHAEOLOGY CONFERENCE

PAUL FORSYTHE JOHNSTON, Editor

Society for Historical Archaeology
Washington, D. C. 1995

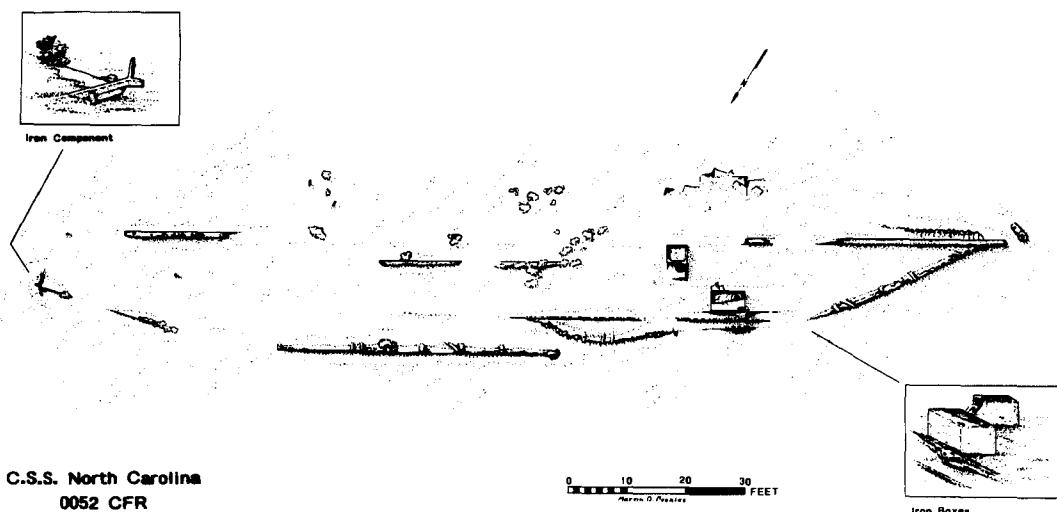
FIGURE 1. Target 1-C, believed to be the remains of the Civil War ironclad *North Carolina*. (Drawing by Martin Peebles.)

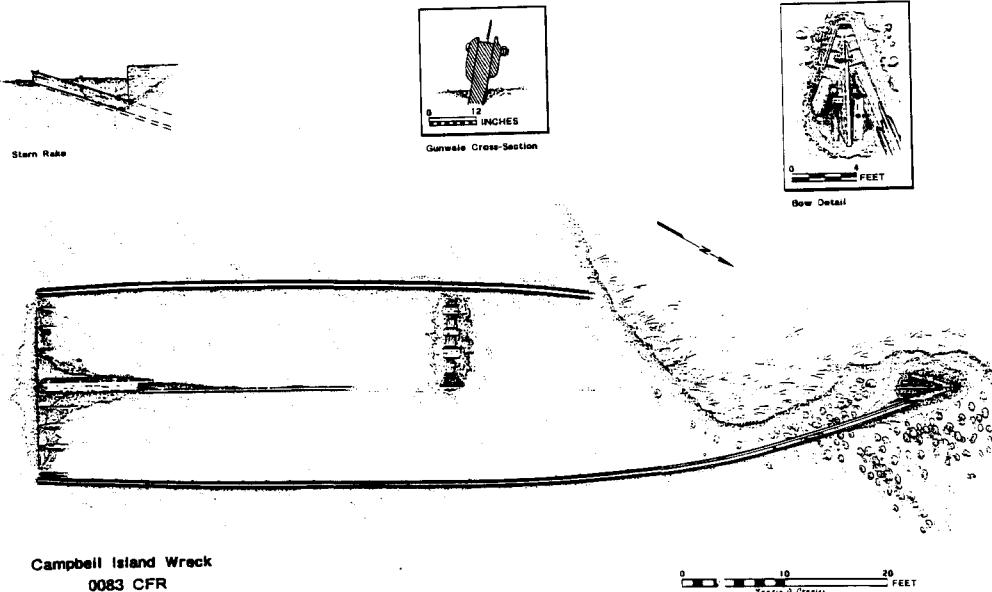
FIGURE 3. Campbell Island wreck. (Drawing by Martin Peebles.)

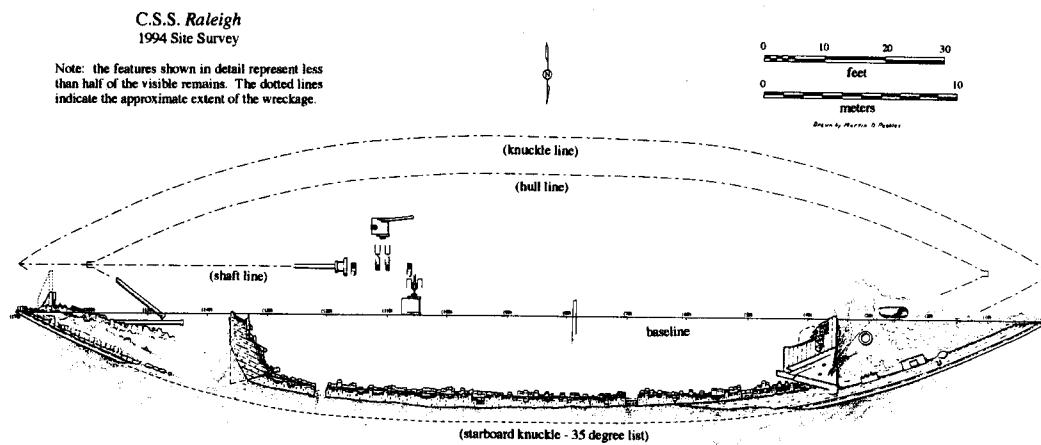
FIGURE 2. 1994 survey plan of *Raleigh* site, detailing starboard features and engine room (only). Port side remains are indicated by original vessel outline. (Drawing by M. D. Peebles.)

Since the engines present the best key to determining the orientation of the wreck's main features, some account of them is necessary before describing the starboard and port sides in more detail (Figures 2 and 3). Finding the engines was surprising, since most accounts suggest that they were salvaged (USGPO 1894-1914:X, 24; Williams and McEachern 1985:3). Only the crank shaft is missing, with the four mounts standing empty between the two cylinders. Segments of the propeller shaft are also strewn about the site. The cylinder arrangement is the same as on three of *Raleigh*'s sister-ships. Commonly referred to as the "direct-acting horizontal" type, these were the preferred engines for *Chicora*, *Palmetto State*, and *Savannah* (USGPO 1922-1927:II, 612; Holcomb 1983:314). Any builder's names remain hidden under marine growth.

Both measured about 18 in. (interior diameter) and were suspended close to the main deck level. In 1994, the hawsepipe was found to have fallen through to the river bottom, as shown in the site plan (Figure 2).

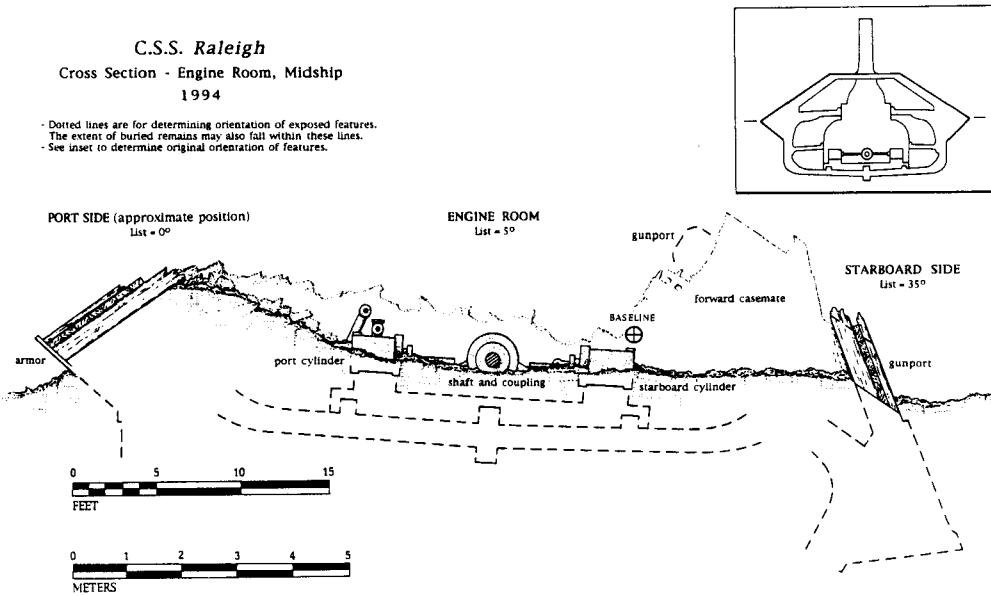
FIGURE 3. Cross-sectional conception of engine room and midship remains. (Drawing by M. D. Peebles.)

The relatively high position of the engine bed (Figure 3) might be explained partly by the original hogging action that "crushed the decks in" (UAU 1864 Peek:26). Hence, the ends of the main hull may rest deeper than the midship section. Like *North Carolina*, *Raleigh*'s lower hull was probably unsheathed. Consequently, both sides of the ship could have collapsed further as a result of erosion and teredo damage. Both sides appear to have settled deep into the river bottom, especially the starboard side which fell over quite dramatically at some point. Angle measurements were taken with a level to deter-

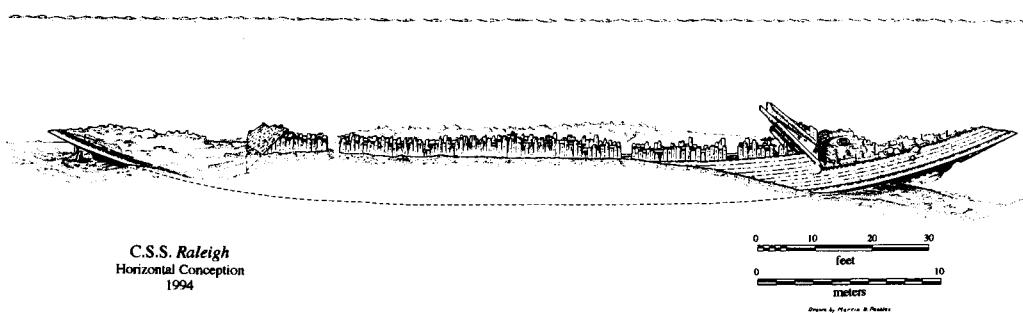
FIGURE 4. Horizontal conception of *Raleigh's* starboard side. (Drawing by M. D. Peebles.)

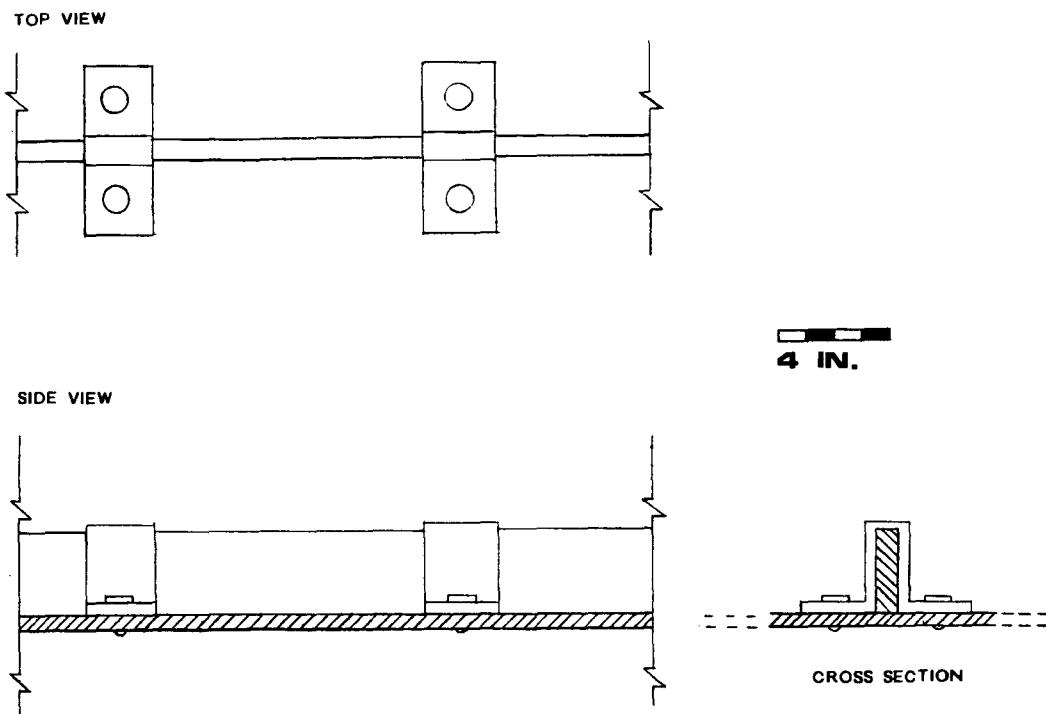
FIGURE 2. Three-view drawing of a typical frame on *Curlew*. (Drawing by Christopher Olson.)

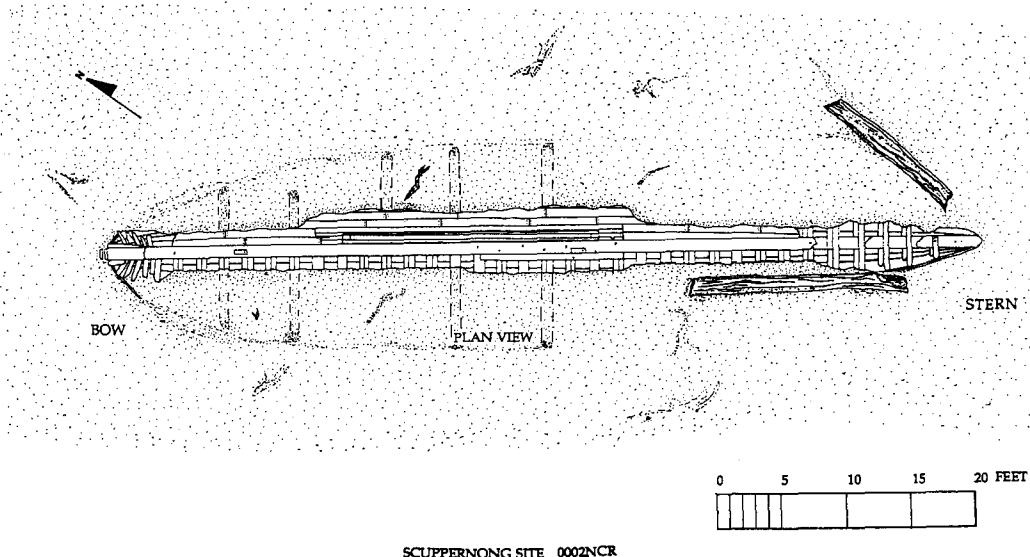
FIGURE 2. *Scuppernong* site plan.

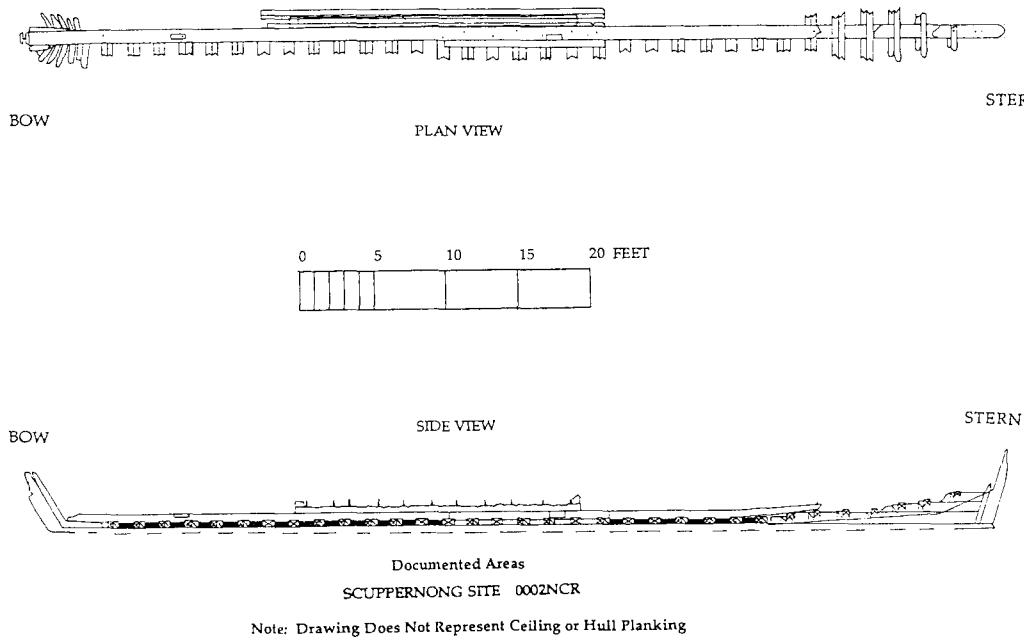
FIGURE 3. Plan and side views of documented areas. The ceiling and hull planking have been omitted.

To facilitate documentation of the vessel's framing pattern, the port side limber board was removed along the entire length of the vessel's keel and keelson (Figure 3). *Scuppernong*'s 33 frames, observed along the keelson and stern deadwood, were a combination of single and double timbers. Based on the placement of 1-in. iron drift pins along the keelson, the floors appeared to be positioned forward of the adjacent first futtocks. While the blocks between frames hindered observation of the first futtocks, the

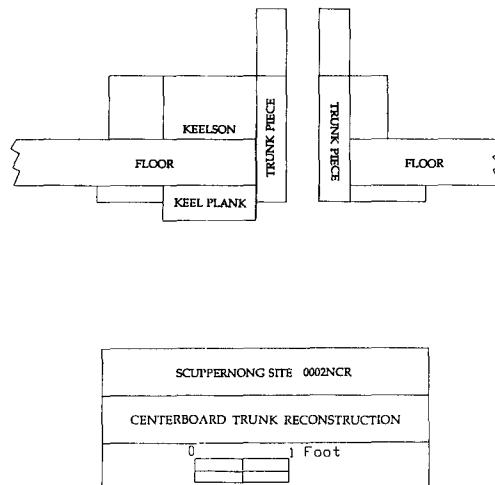
FIGURE 4. Centerboard reconstruction.

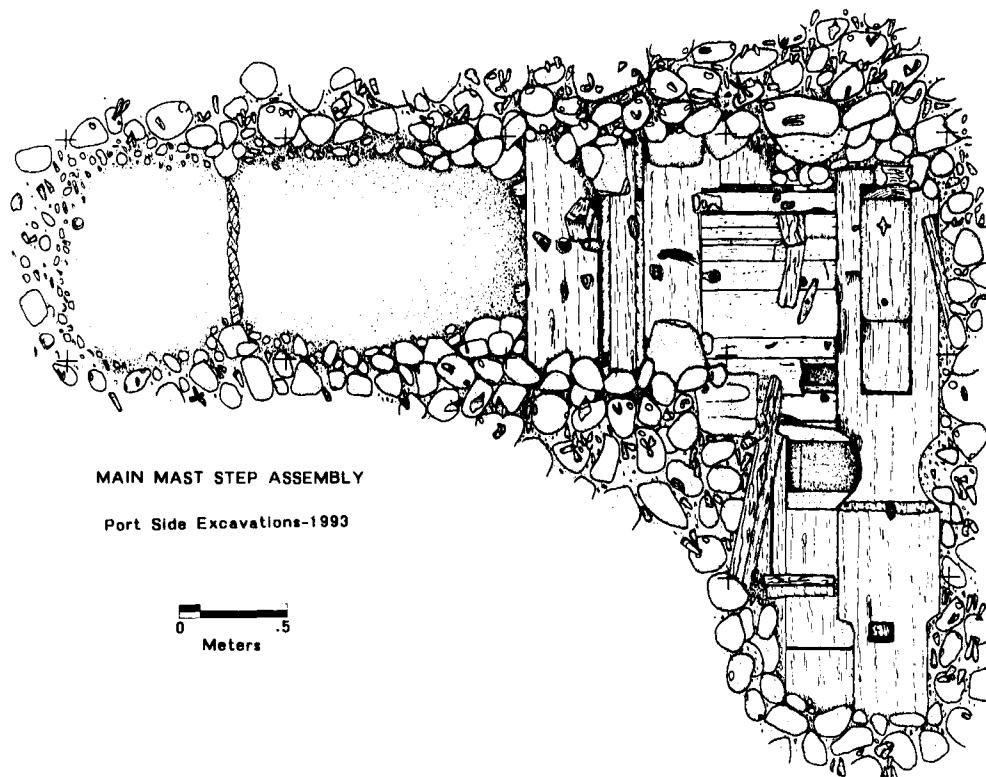
FIGURE 1. Plan view of main mast step assembly.

The principal feature exposed in the port amidships of the galleon was the mainmast step and associated timbers, which exhibit characteristic 16th-century architecture (Figure 1). Composed of an enlarged and thickened section of the keelson, the step has a large mortise to house the mainmast's tenon. Inside the mortise

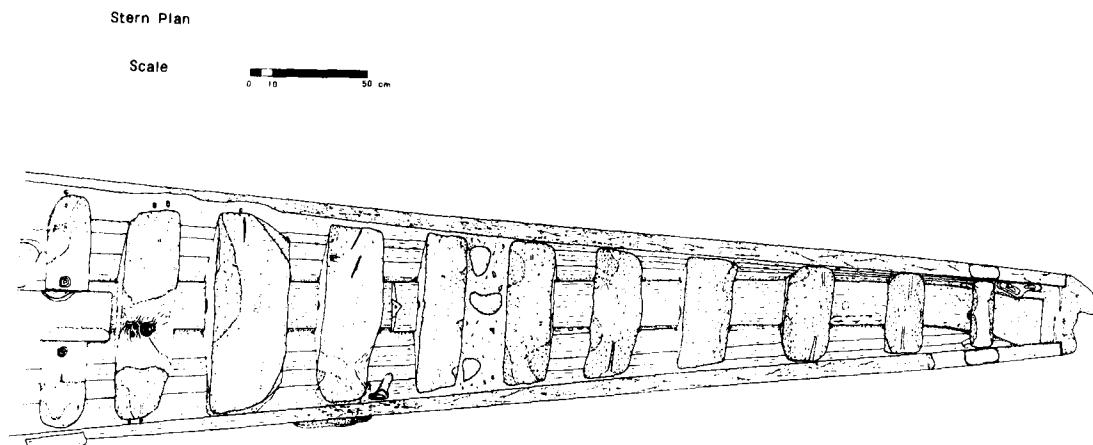
FIGURE 2. Plan view of stern section.

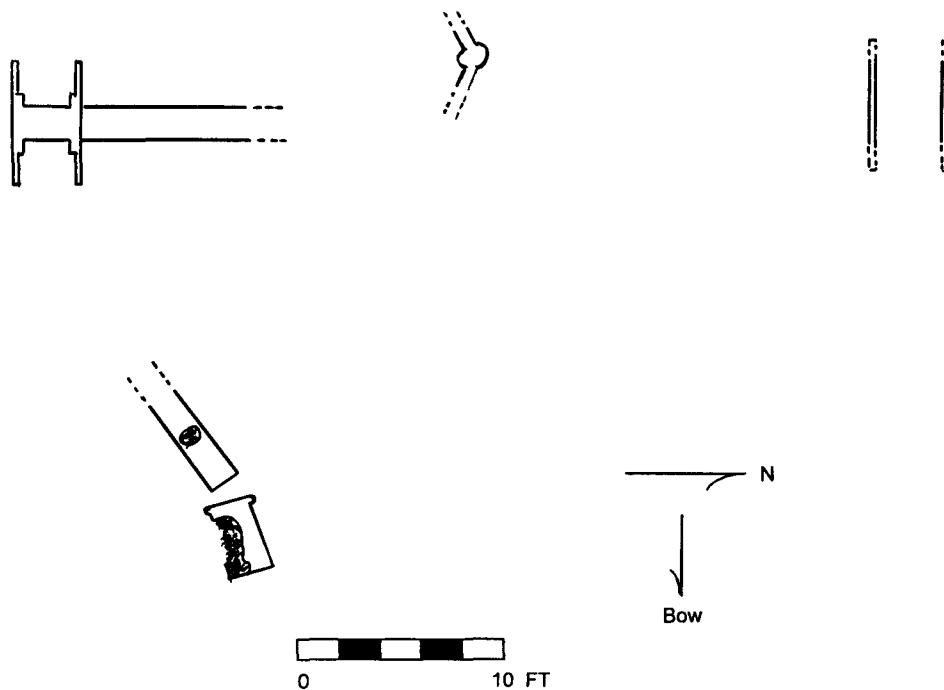
FIGURE 1. Preliminary site plan of the USS *Hatteras* wreck.

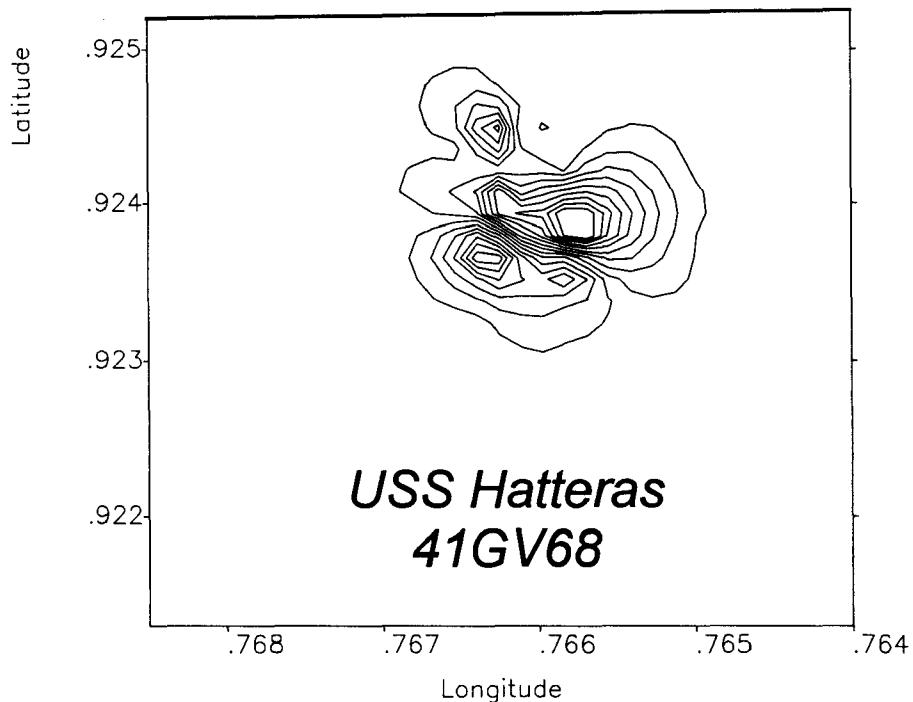
FIGURE 2. Contour plot of magnetometer data from USS *Hatteras*. One hundred gamma contours. (Surfer for Windows software provided by Golden Software.)

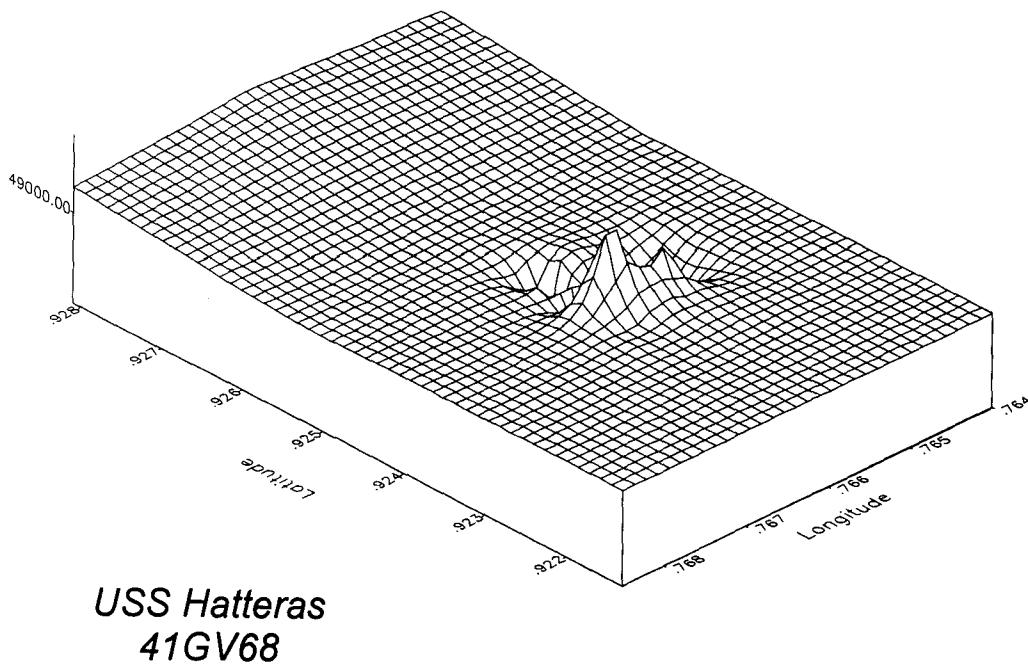
FIGURE 3. Three-dimensional plot of the magnetometer data from *USS Hatteras*. (Surfer for Windows software provided by Golden Software.)

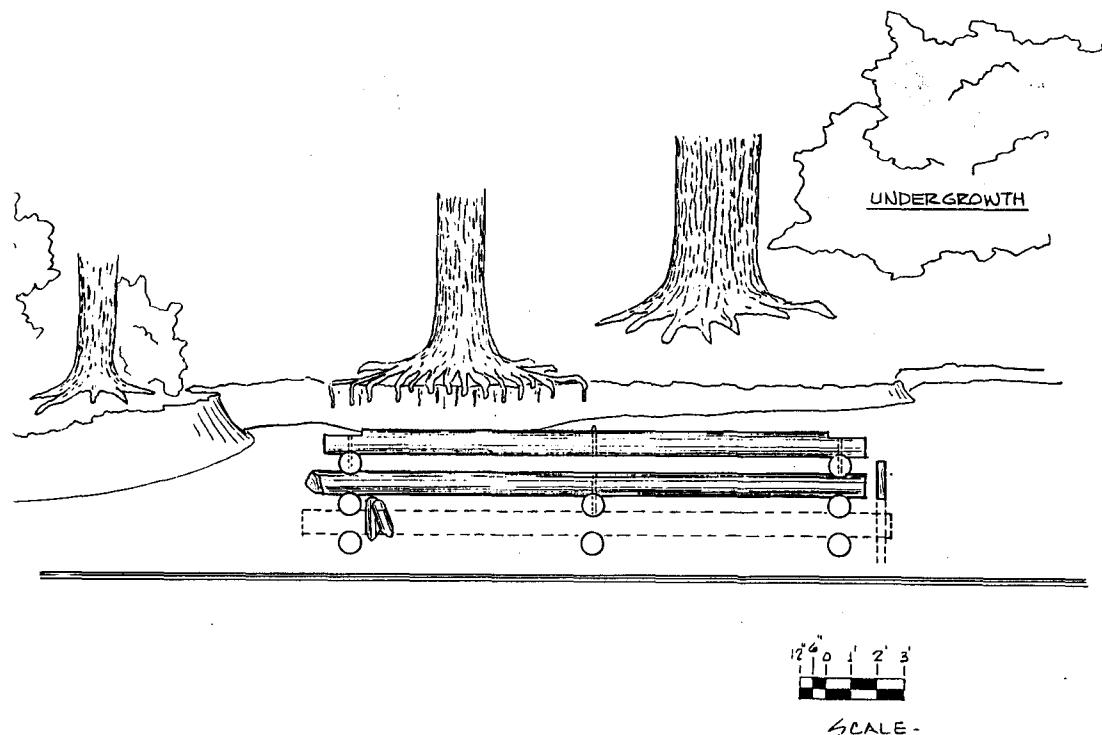
FIGURE 1. Reconstruction of "Baker's Wharf" on Ashley River, Old Dorchester. (Drawing by William R. Judd.)

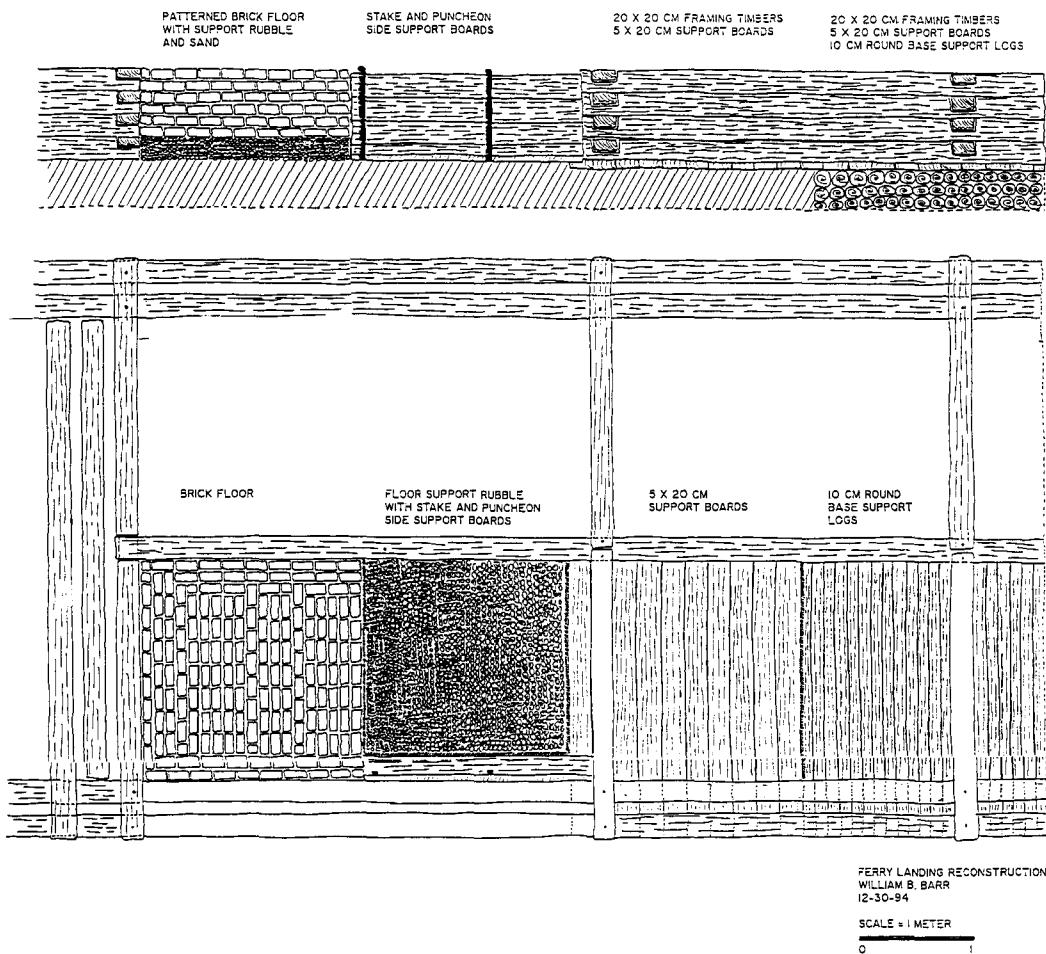
FIGURE 2. Preliminary construction typology for northwest landing of Strawberry Ferry. (Drawing by William B. Barr.)

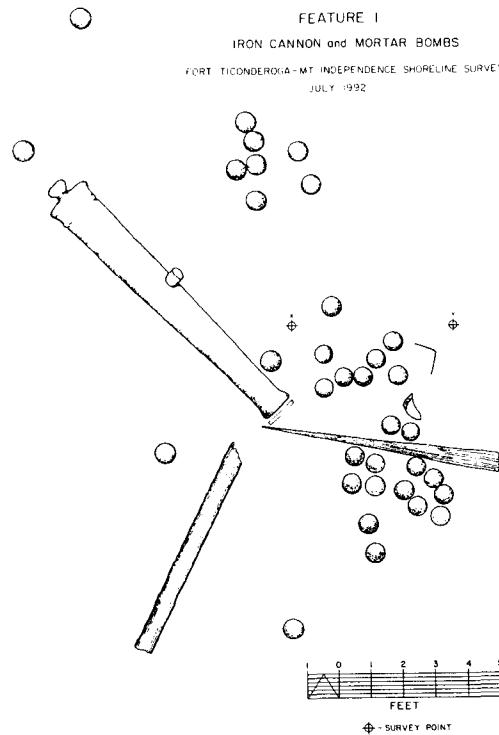
FIGURE 2. Archaeological drawing of Mt. Independence Feature 1, detailing the relationship of the 12-pound iron cannon and mortar bombs on the lake bottom. (Drawing by John Bratten and Kevin Crisman.)

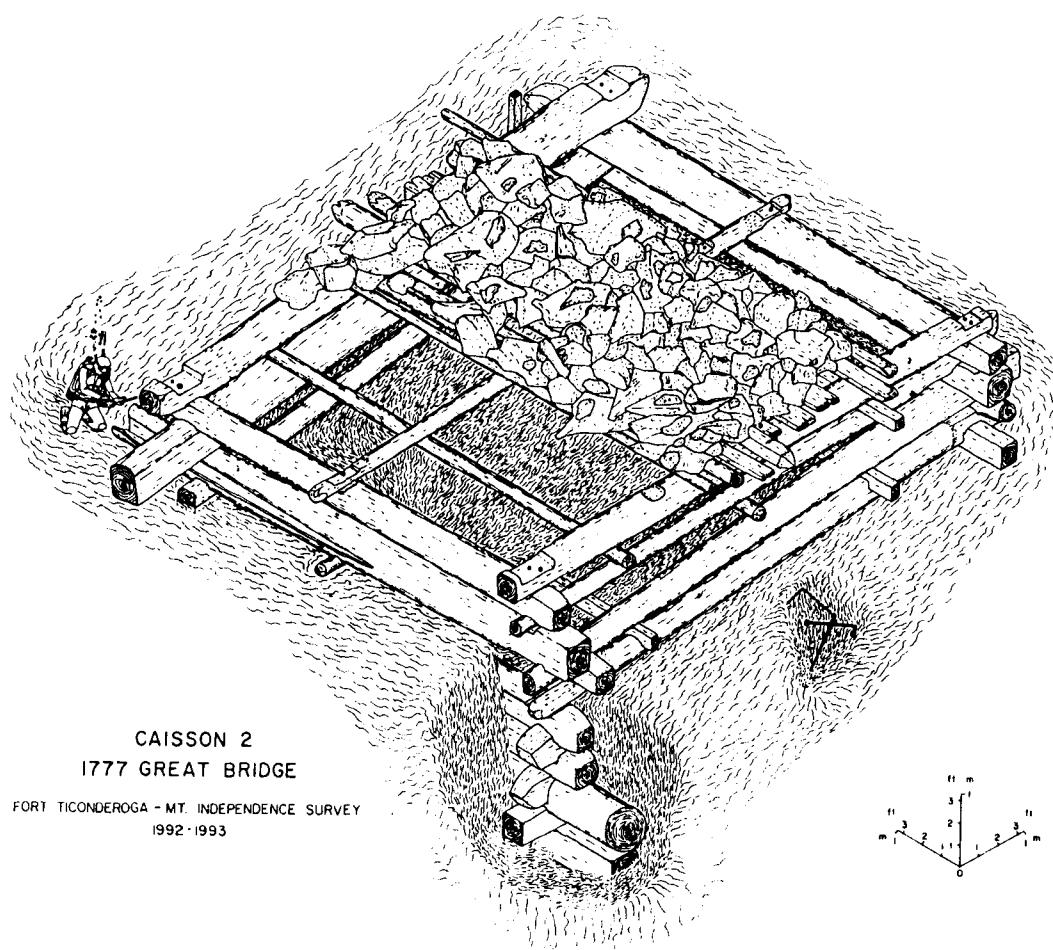
FIGURE 3. Archaeological reconstruction of Caisson #2. (Drawing by Joe Cozzi.)

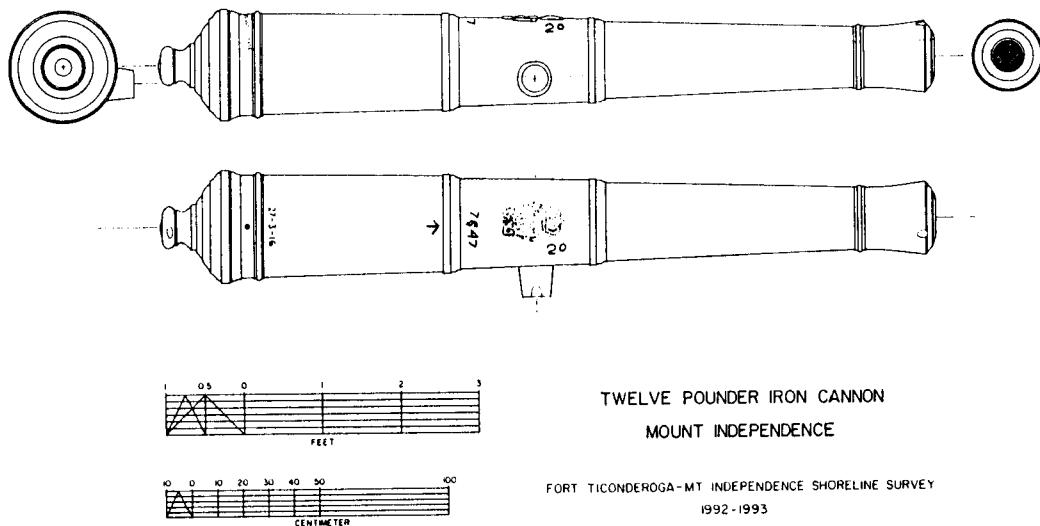
FIGURE 4. Drawing of the conserved Mt. Independence cannon. Preliminary identification of the cipher indicates the cannon is a rare example of a Scottish Naval gun, ca. 1670. (Drawing by Scott McLaughlin.)

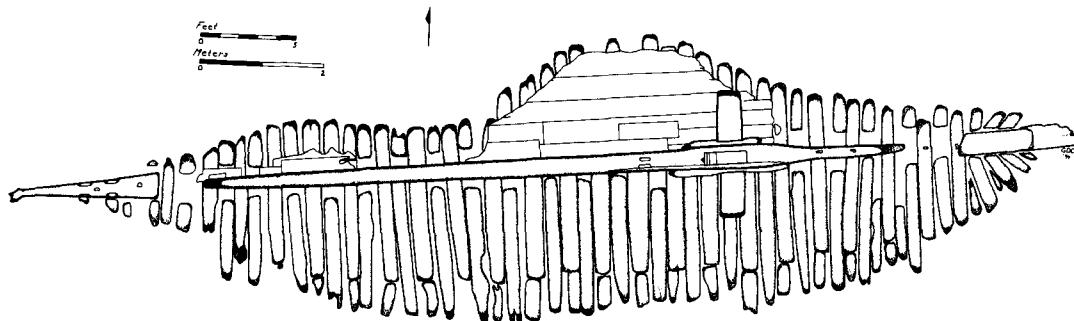
FIGURE 2. Site plan of the Reader's Point sloop. Note the radial cant frames in the bow, the mast step construction, and the grown knee timber in the stern.

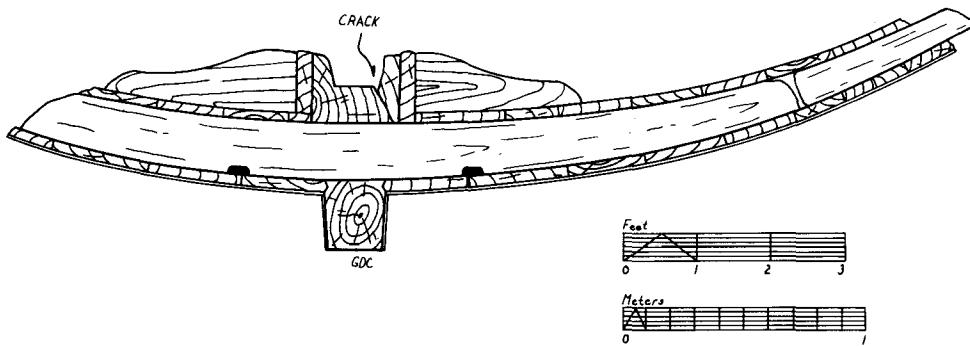
FIGURE 3. Profile of the Reader's Point sloop at the mast step. Note the crack running through the mortise and the associated repair timbers.

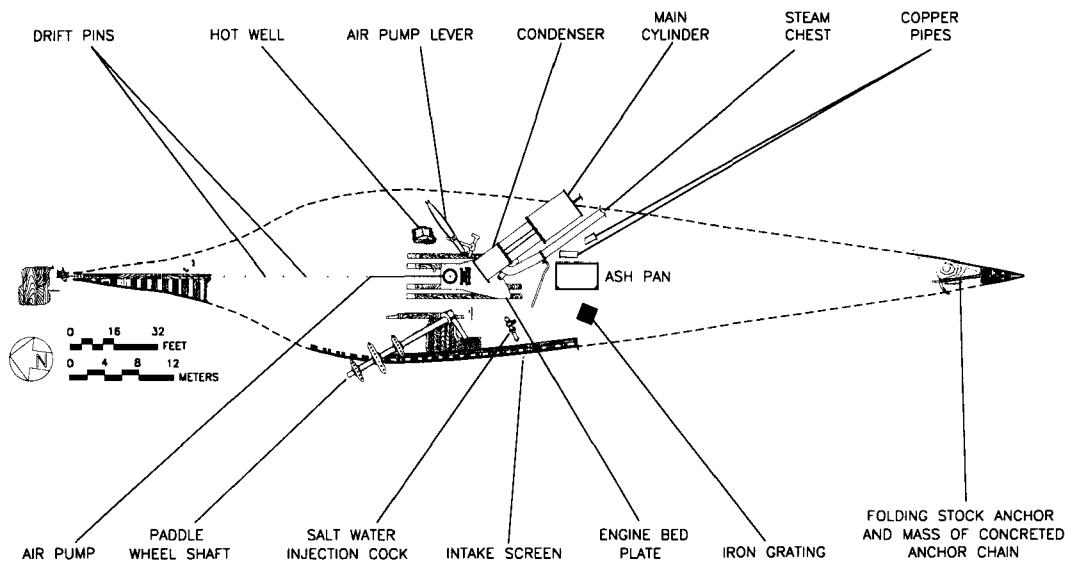
FIGURE 2. Site plan of *Columbus*.

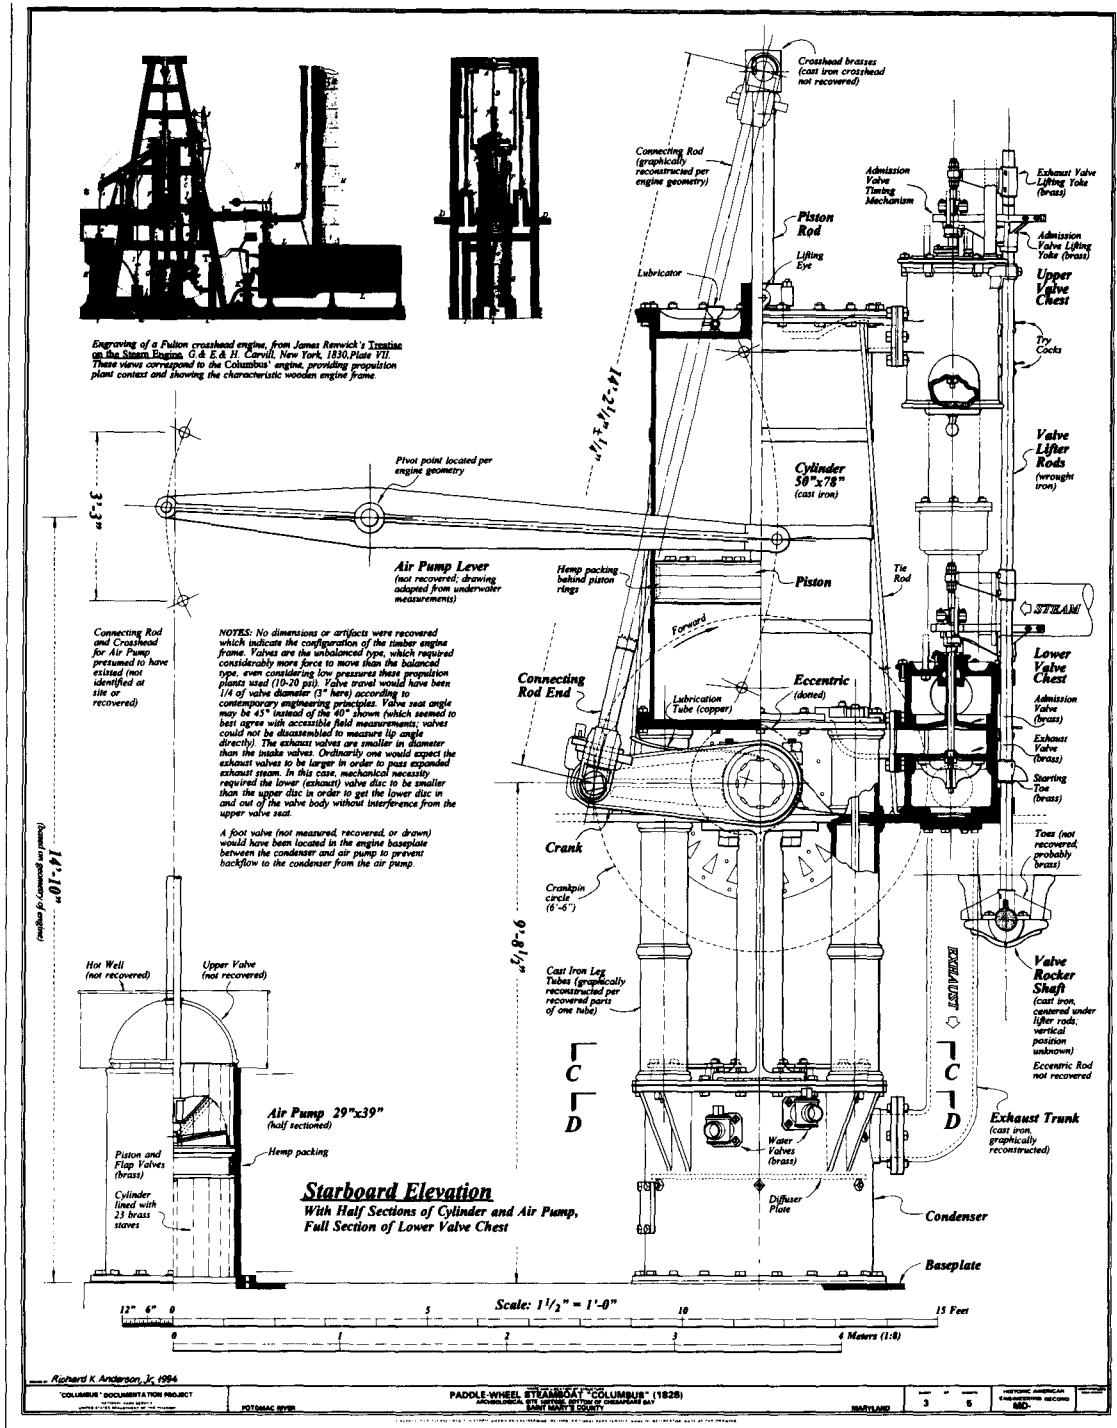
FIGURE 3. The cross-head steam engine of *Columbus*, based upon recovered remains.

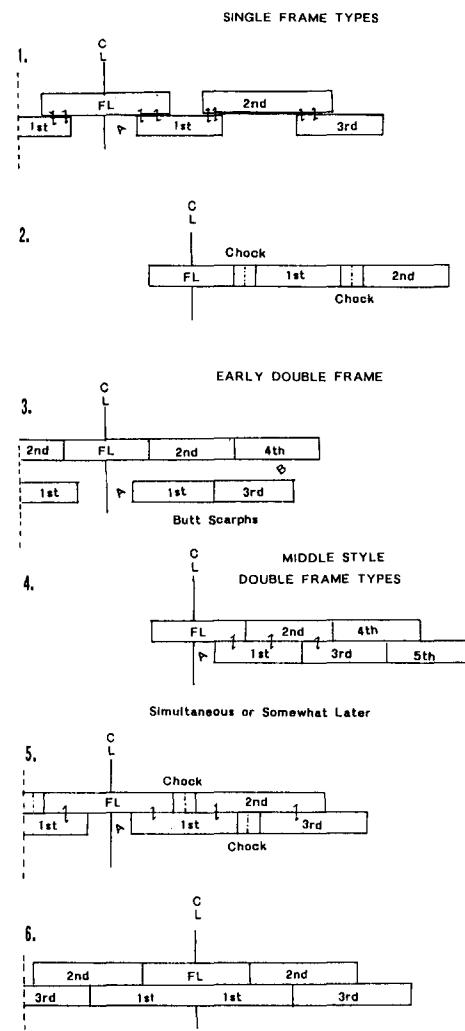
FIGURE 2. Basic 18th-century framing pattern evolution.

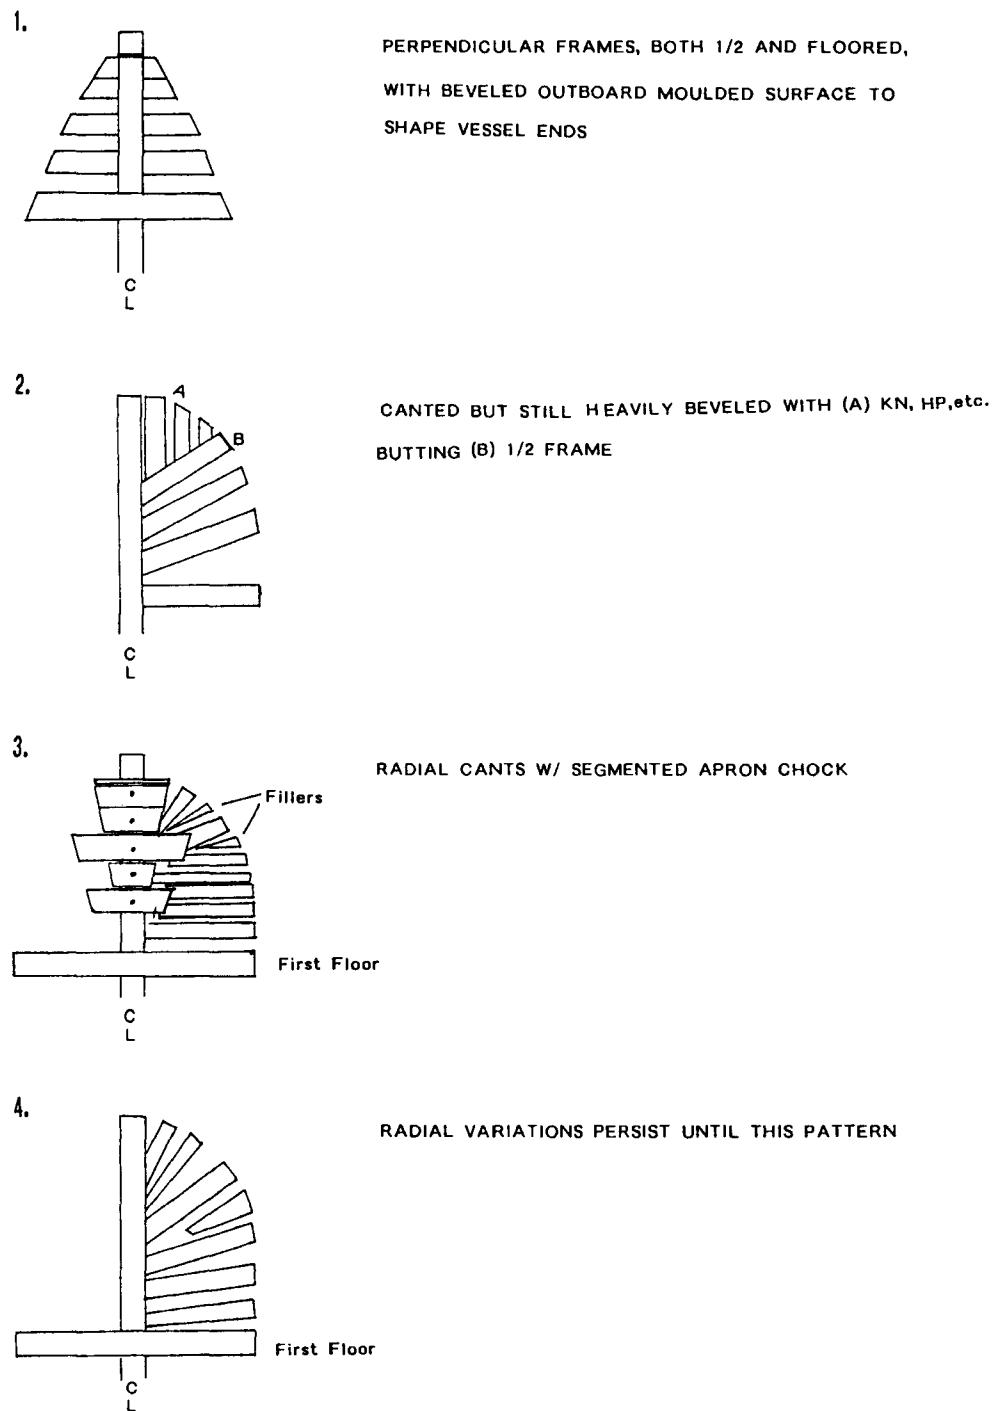
FIGURE 3. Basic evolution of bow cant frames.

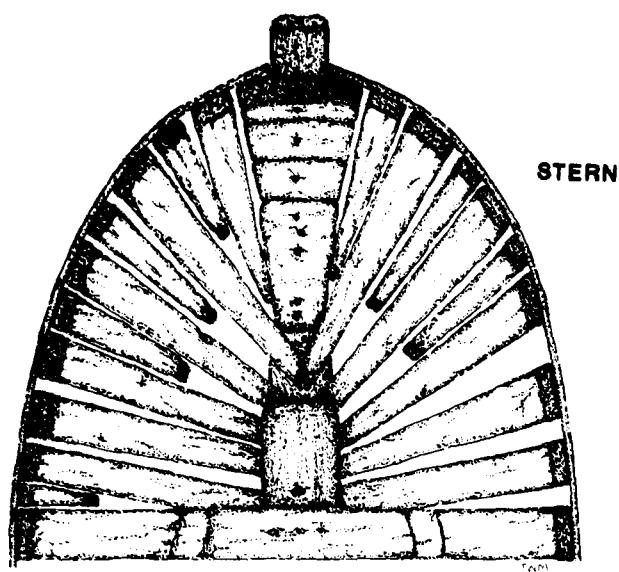
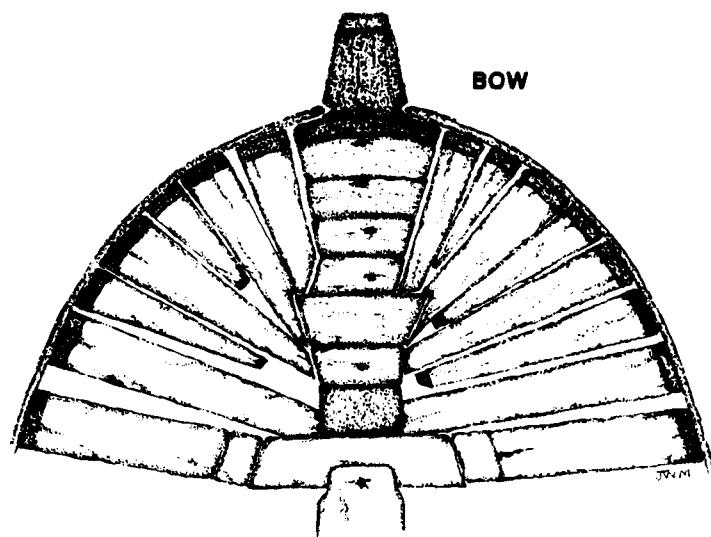
FIGURE 4. Bow and stern cant frames on *Betsy* (Morris 1991:98).

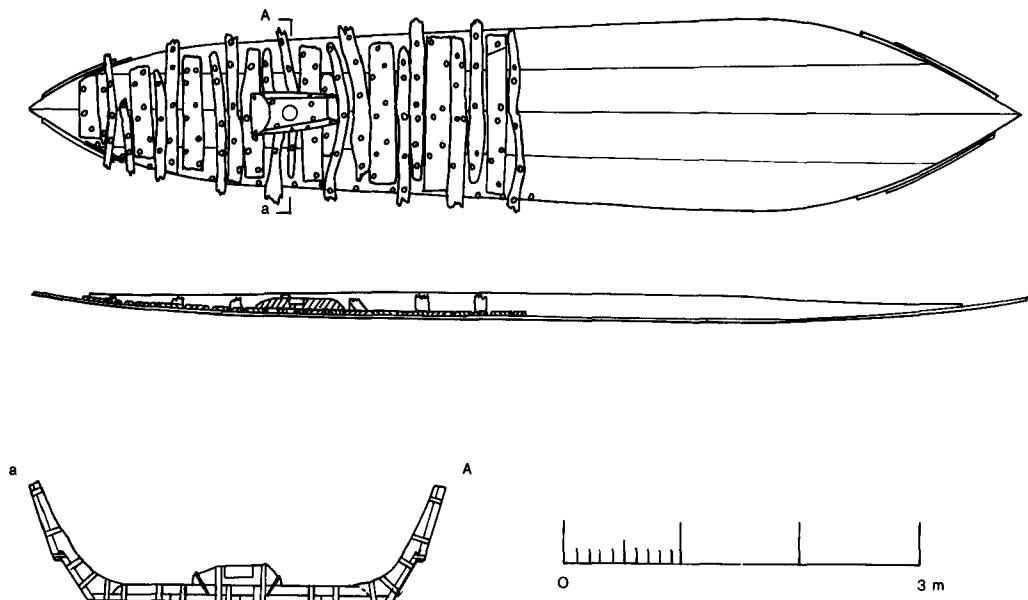
FIGURE 1. Remains of 13th-century vessel from Meinerswijk in the Netherlands. The bow is the narrower end, where the mast step is located. Cross-section is reconstructed. (Drawing by author, after Reinders 1983.)

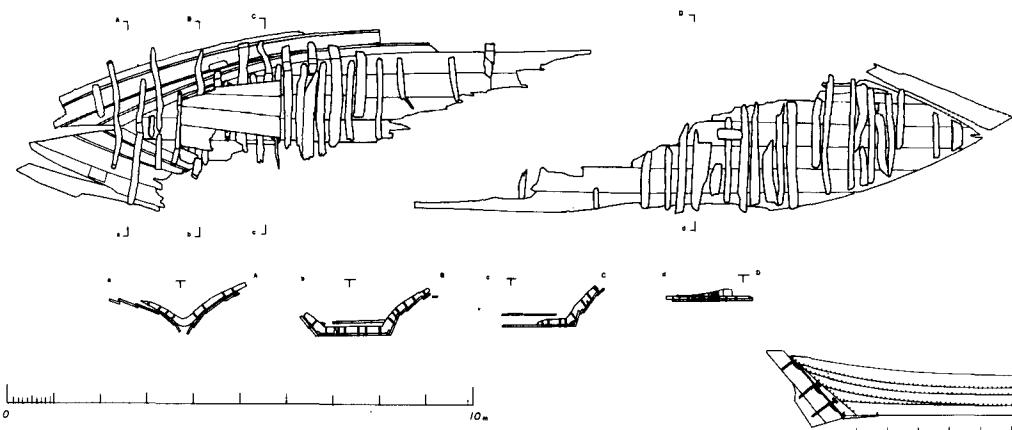
FIGURE 2. Remains of the late 15th-century pram B 55. The mast step was placed in the large frame, shown in section d-D at the far right. The stern, of which a reconstruction is shown, was better preserved than the bow. (Drawing by author, after Reinders 1986.)

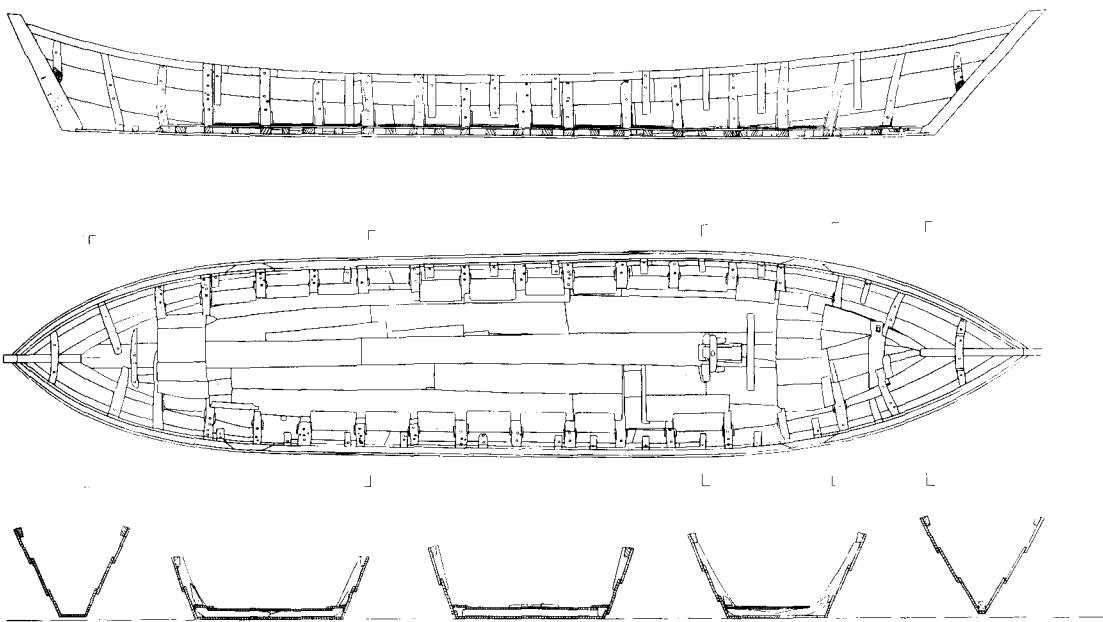
FIGURE 3. Reconstruction of 16th-century pram discovered near Workum, Friesland. Drawing not to scale. (Drawing by author.)

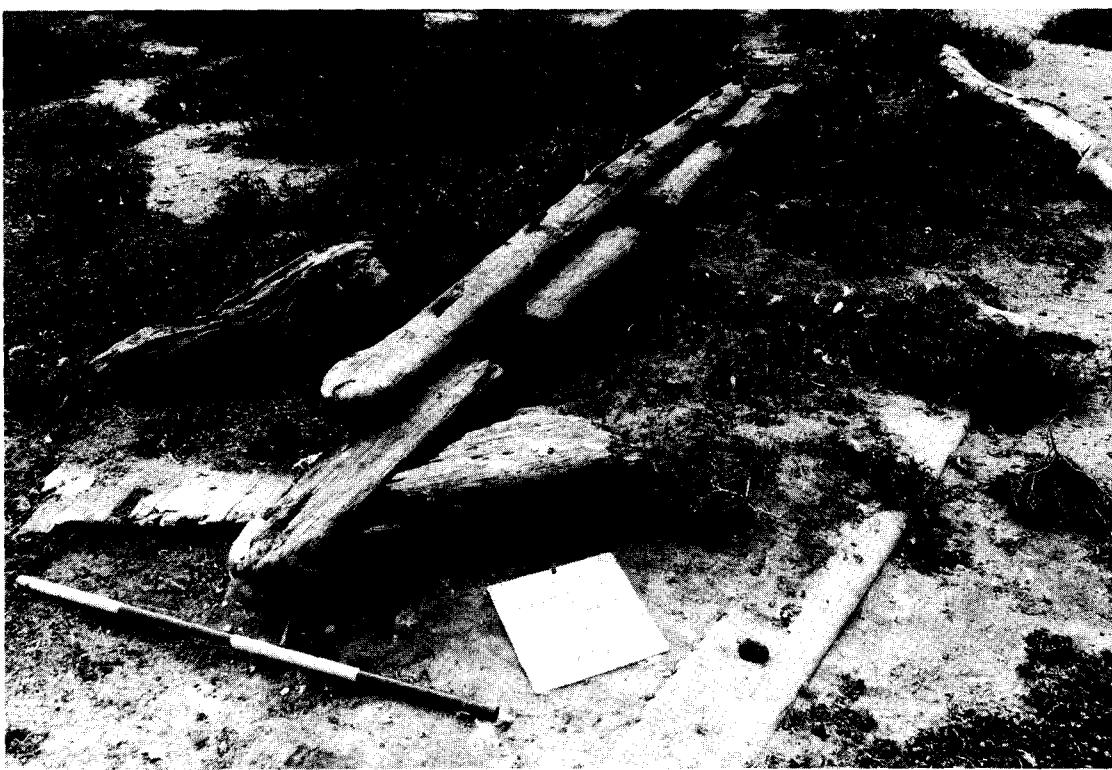
FIGURE 2. Possible deck clamp from *J. M. Colman*.

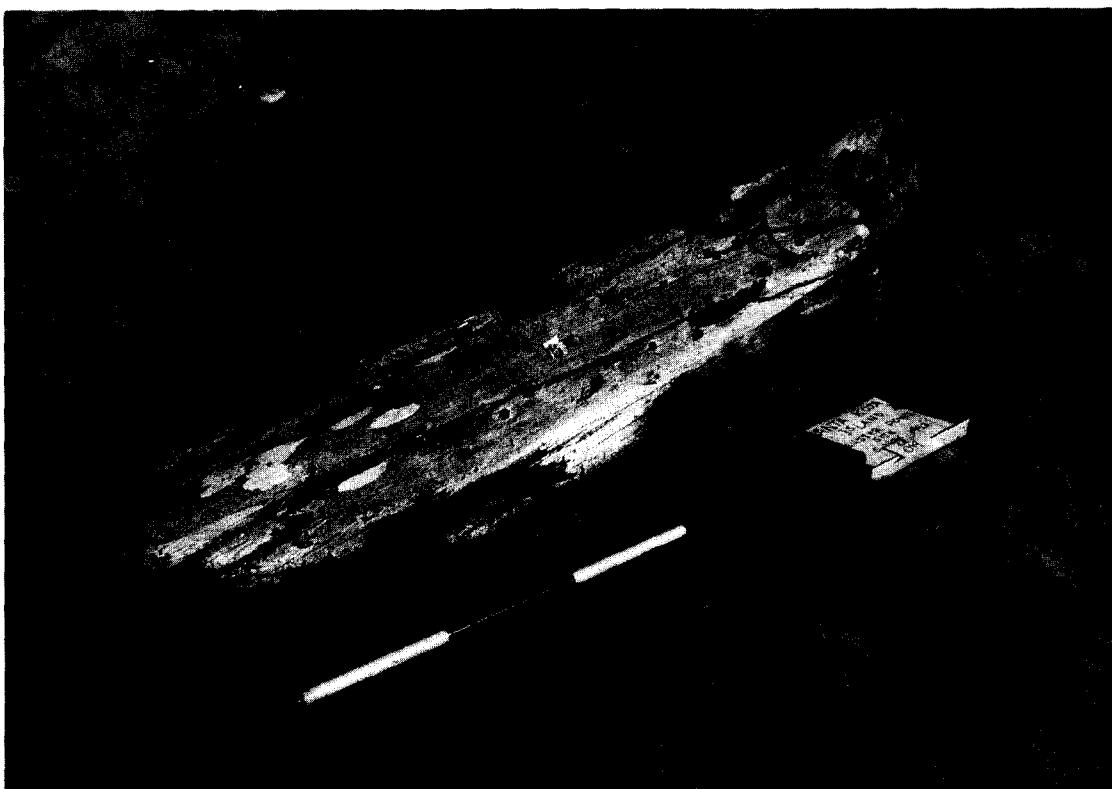
FIGURE 3. Possible poop-deck clamp from *Dora Bluhm*.

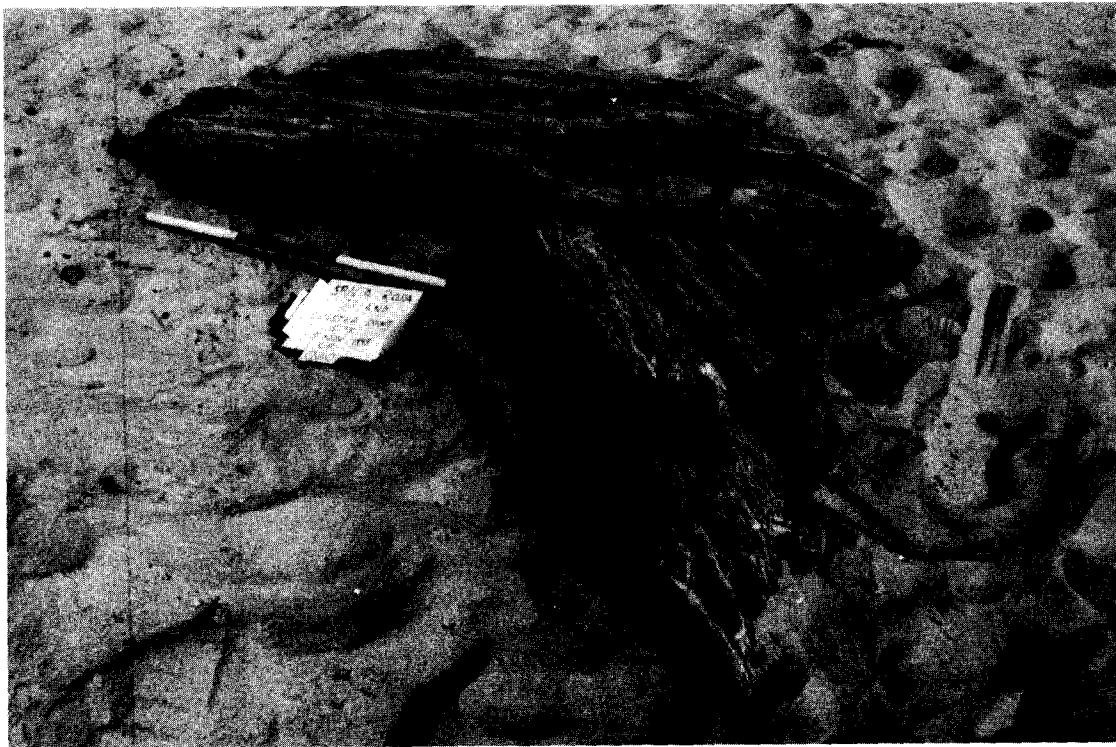
FIGURE 4. Possible stern element from *Dora Bluhm*.
