UNDERWATER ARCHAEOLOGY PROCEEDINGS
FROM THE SOCIETY FOR HISTORICAL
ARCHAEOLOGY CONFERENCE

PAUL FORSYTHE JOHNSTON, Editor

Society for Historical Archaeology
Washington, D. C. 1995

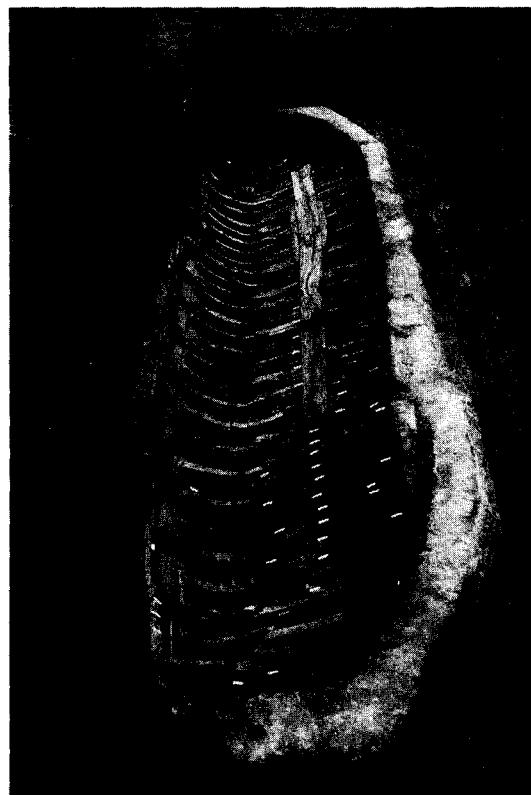
FIGURE 1. The H 107 wreck viewed from the stern. The port side was well preserved, but the starboard side had virtually disappeared. Two mortises in the mast step are for the ends of the tabernacle planks, which supported the mast. (Photo by R. Neyland.)

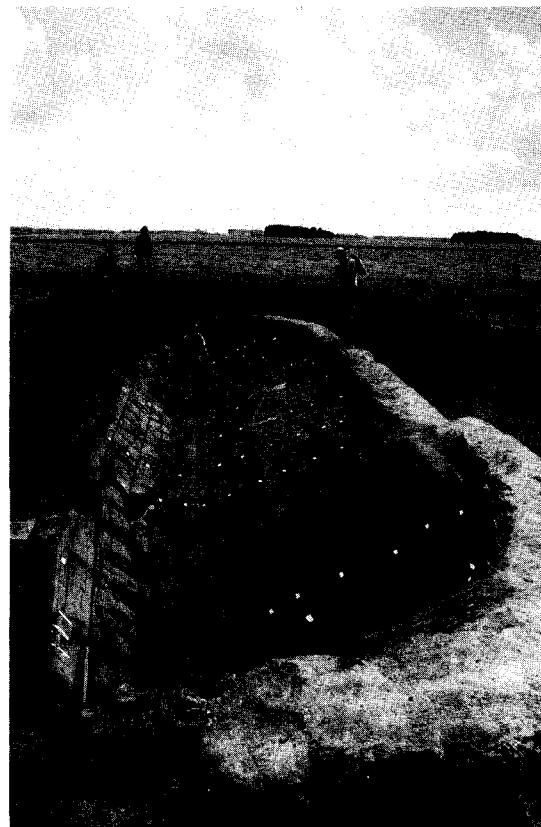
FIGURE 2. Viewed from the stern, H 107 as it appeared after removal of the frames. The hole on the starboard side was left by a ditching machine, which led to the 1968 wreck discovery. Excavation team members clean the hull in preparation for recording. (Photo by R. Neyland.)
